TECHNICAL BULLETIN

No: LA-501-006

A-pillar Water Leak

Land Rover LR3 (LA)

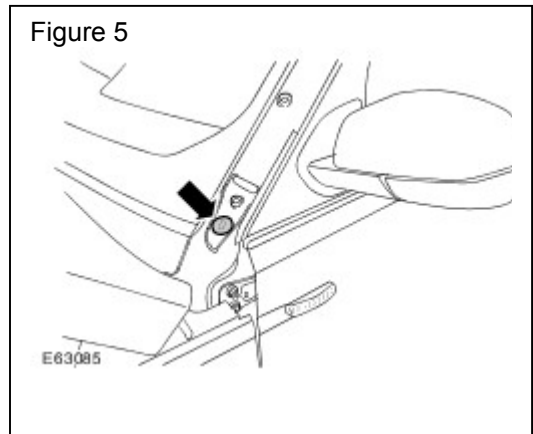
Figure 5

Situation: A customer may report water in the footwell of the vehicle. Water ingress through the lower slot in the A-pillar structure, where the exterior trim lower location peg slots into the body, may be the cause. The customer may also report unexplained illumination of warning lights such as the oil pressure warning lamp.

6. Clean area surrounding the lower elongated slot in A-pillar structure
7. Apply adhesive patch, supplied in kit DHB500400, to body covering lower elongated slot. (Figure 5)
8. Attach clip IPN500050 to the lowermost A-pillar exterior trim mounting location. (Figure 6)
9. Install 4 clips (DZM000070) to the remaining A-Post exterior trim mounting locations. (Figure 7)
