TECHNICAL BULLETIN

No: LA-419-002
Issue: 1
Date: 10 Nov 2005

KIT Accessory Phone Module Fault

Land Rover LR3 (LA)

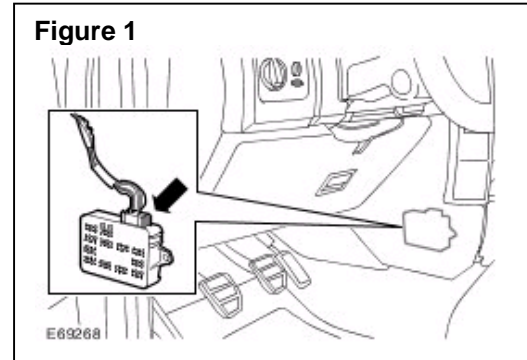
A customer may report a concern that when the ignition is switched on or off, the navigation system voice announces 'sorry' or 'command not recognized'.

Cause: This is a phone system component software error.

1. Release center floor console upholstery for access.
2. Release the cellular telephone module from the Velcro® retaining strips.
3. Remove the cellular telephone module from behind the floor console. (Figure 1)
4. Disconnect the cellular telephone module electrical connector. (Arrowed in Figure 1)
5. Remove the cellular telephone module.
6. Attach Velcro® strips to the new cellular telephone module (XVD500021).
7. Position the cellular telephone module behind the floor console and attach to the Velcro® retaining strips.
8. Install center floor console upholstery.
