### INSPECT FOR WATER CONTAMINATION AND REPAIR

# TECHNICAL BULLETIN

No: LTB00054  
Issue: 1

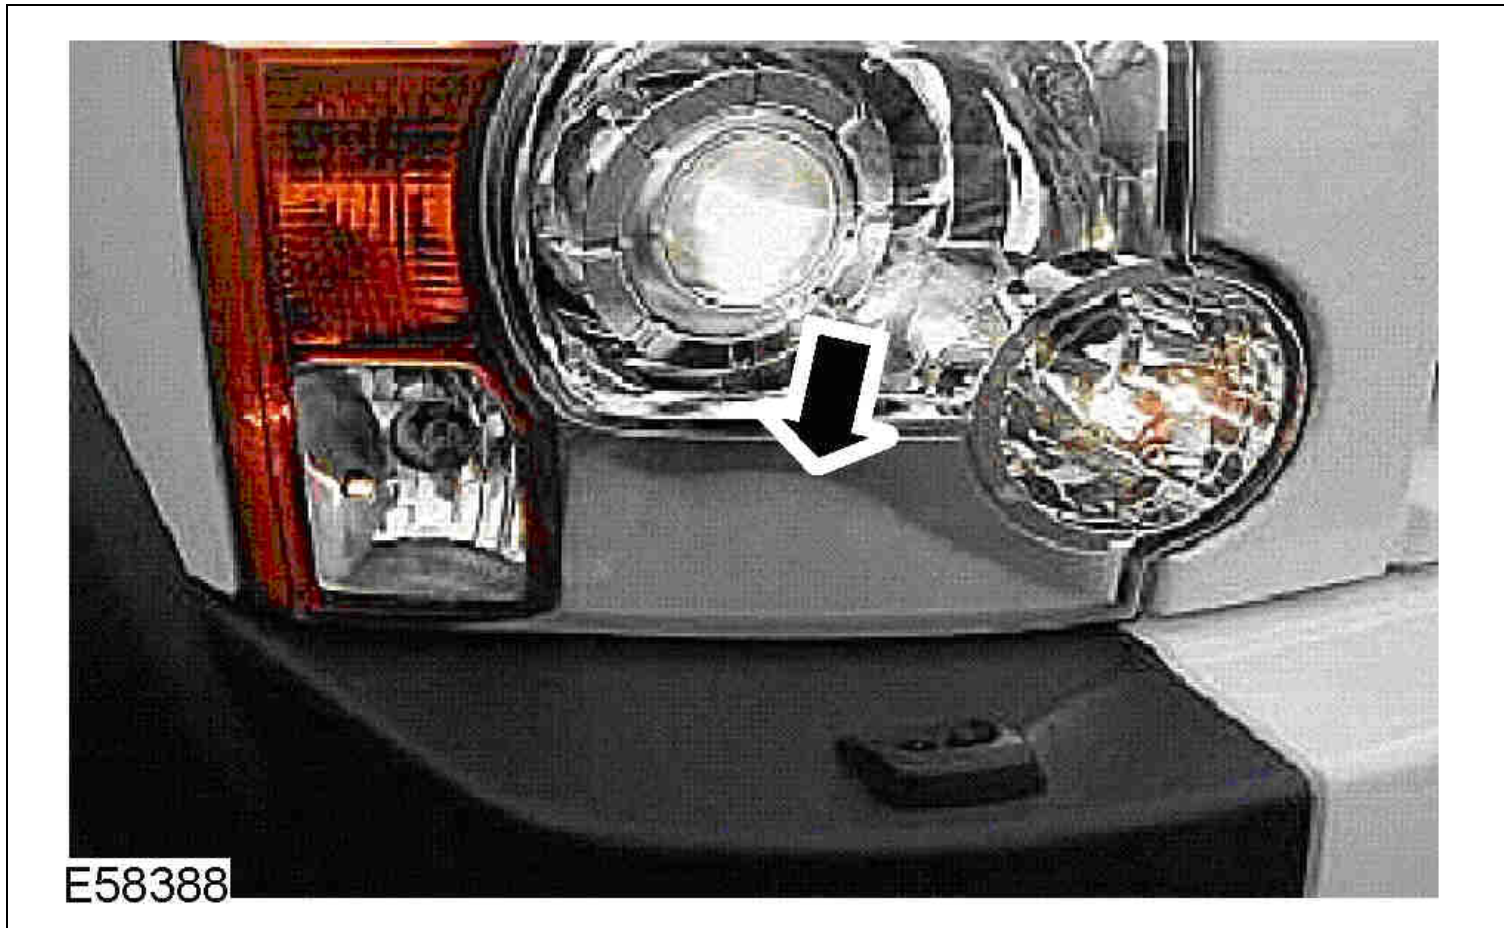
## Illustration Attachment 4 Headlamp Condensation NOT Covered by Warranty -

1. Verify that the lamp meets the "non-warrantable" conditions in Attachments 4 through 7.
2. Remove the affected lamp from the vehicle.

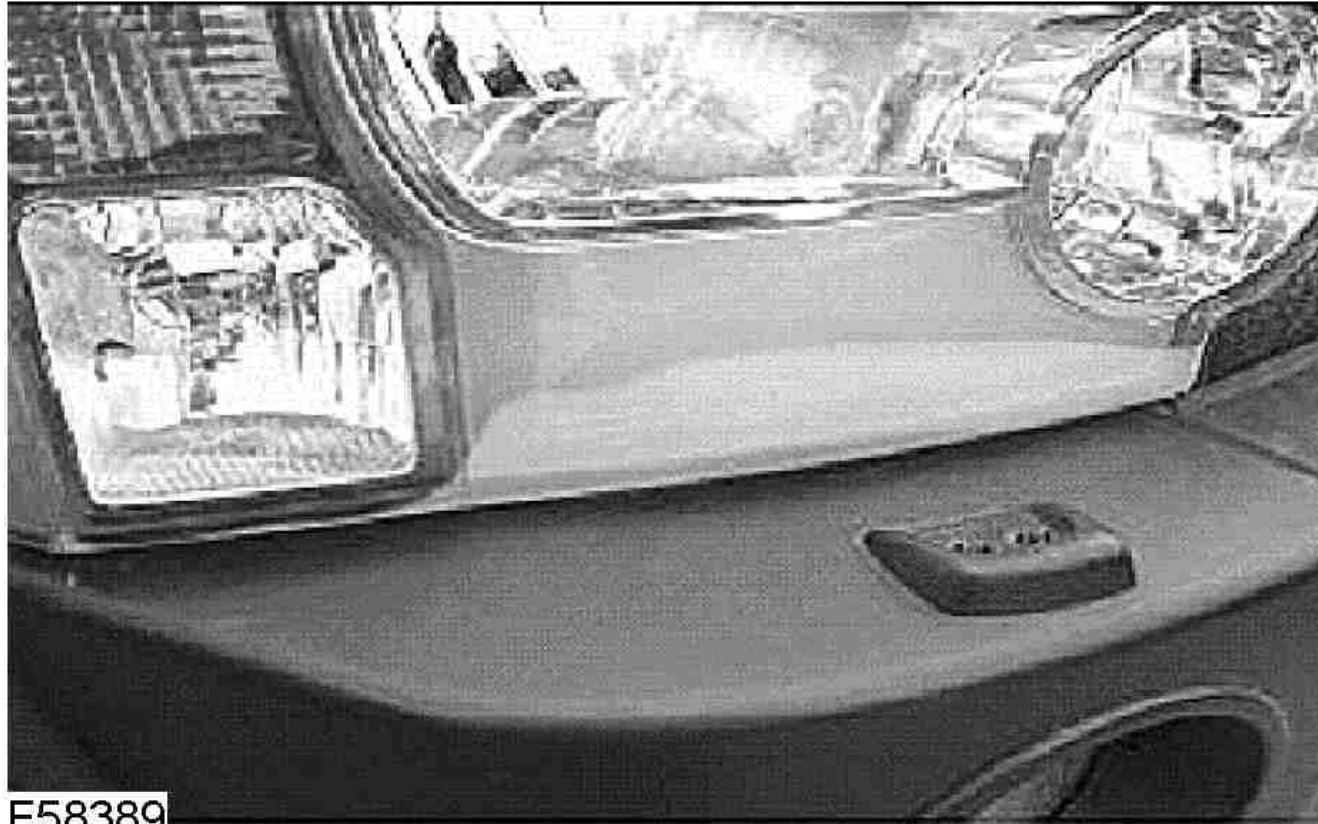
## Illustration Attachment 5 Headlamp Condensation NOT Covered by Warranty

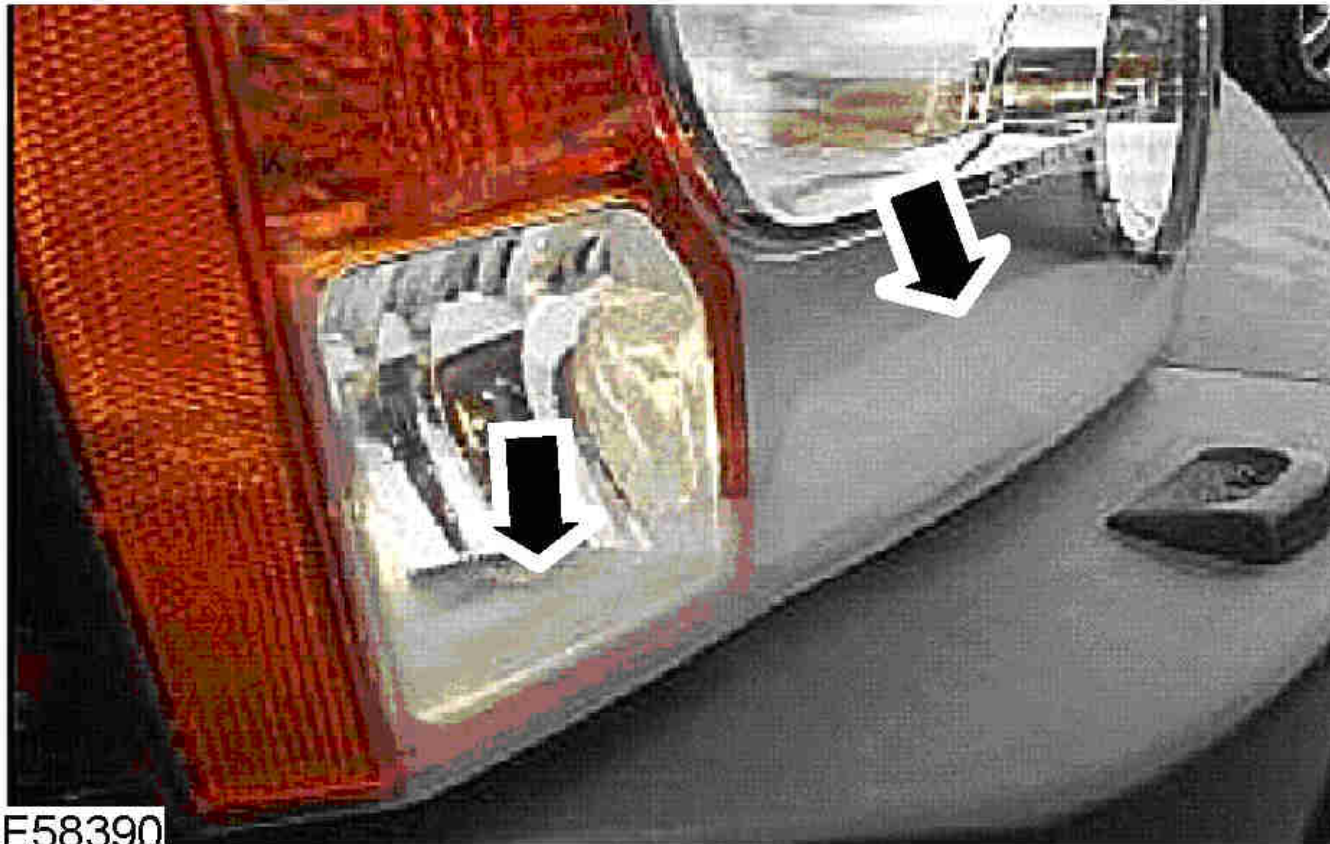
## Illustration Attachment 6

Headlamp Condensation NOT Covered by Warranty (Mist does not obstruct the view of the lamp's interior)

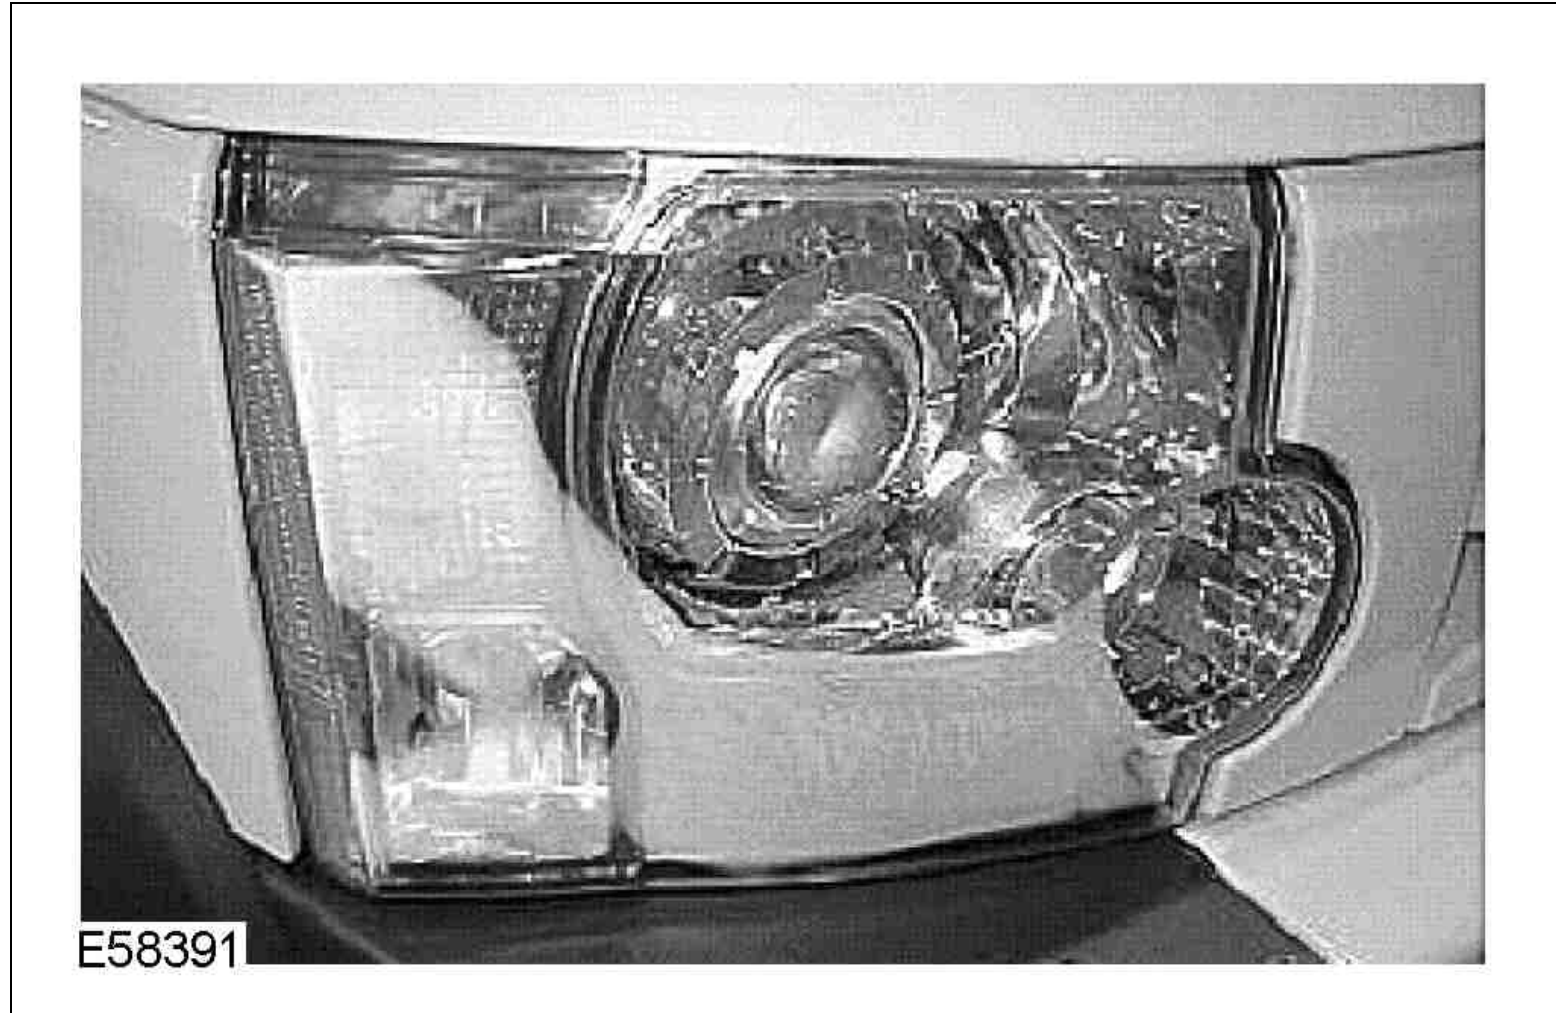
## Illustration Attachment 7

Headlamp Condensation NOT Covered by Warranty - 4 (Fine mist covers less than 50% of the lens)
