TECHNICAL BULLETIN

No: LTB00122
Issue: 1
Date: 10 MAR 2008

Engine Coolant Fill / Bleed Procedure

AFFECTED VEHICLE RANGE:

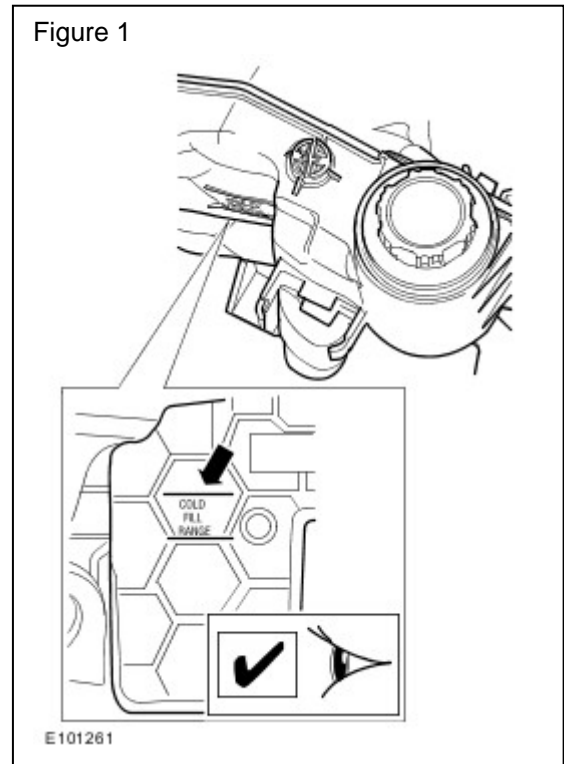
Figure 1

Situation: A condition may occur where the low coolant level warning message or lamp is illuminated. This condition could be caused by an incorrect coolant level in the coolant expansion tank due to air being trapped in the system.

2. Verify the coolant level by viewing the side of the expansion tank. (Figure 1)
3. If the engine temperature is cold (gauge on 'C') the coolant level must be at the top of the 'COLD FILL RANGE'. (Figure 2)
 - If necessary, top up the cooling system to the correct level with coolant.
