TECHNICAL BULLETIN

No: LA-501-014

Front Door Exterior Trim Detachment

LR3 (LA)

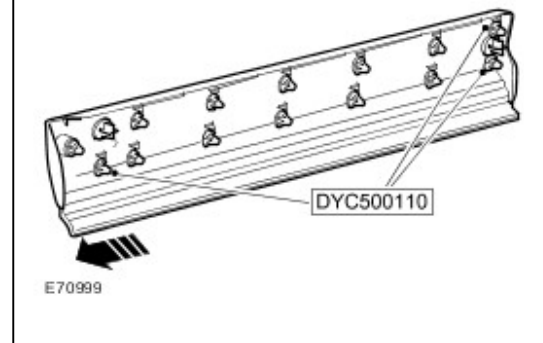
Figure 1

A customer may report a concern that the lower door exterior trim moulding on the front doors has become partially detached from the door.

Cause: Incorrect assembly of the lower trim during assembly can produce a situation where clips do not fully engaged in the door. Separation of the 2-piece retaining clips can also occur. These conditions can result in partial detachment of the trim from the door.

1. Release the exterior lower door panel trim retaining clips and remove the trim.
2. Remove and discard the fourteen used clips.
3. Replace the retaining clips as follows: (Figure 1)
 - Install the three new clips (DYC500110) in the positions shown in the illustration. (**BOLD** arrow indicates front of vehicle).
 - Install new clips (DYC101420) in the remaining eleven clip locations on the finisher.
4. Install the finisher ensuring all fourteen clips engage correctly and are secure.
