TECHNICAL BULLETIN

No: LTB00067
Issue: 4
Date: 07 APR 2009

'Chirp' Noise on Engine Cold Start - Repair Procedure

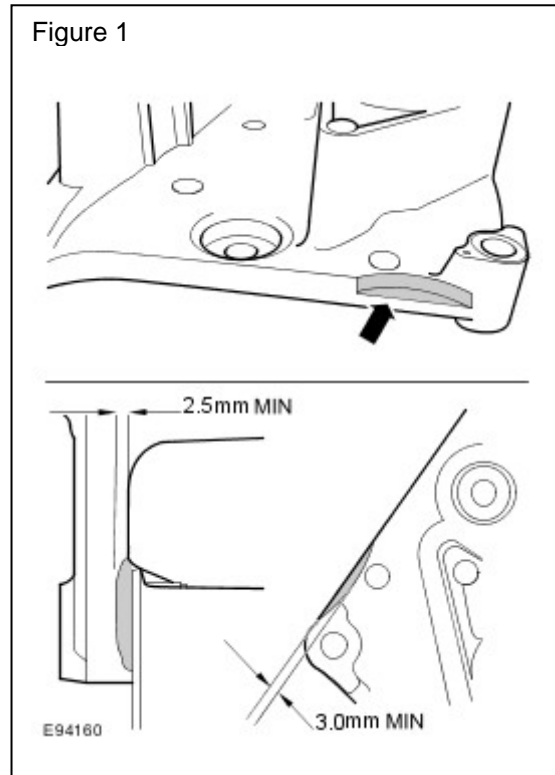
Figure 1

Situation: On vehicles equipped with the 4.2L / 4.4L V8 engine, a 'chirp' noise on engine cold start heard coming from the front end accessory drive (FEAD) belt may be due to the belt 'wandering' on the idler pulley.

1. Refer to Workshop Manual (GTR) Section 303-05 (86-10.03) to remove the idler pulley and FEAD belt.
2. Undo the five bolts and remove the fan pulley bracket.
3. Place the fan pulley bracket in a vice.
4. Modify the bracket using a suitable file or grinding tool as illustrated. (Figure 1)
5. Install the fan pulley bracket and tighten bolts to **22-28Nm (16-20.5 lbf ft)**.

6. When the new idler pulley is installed, verify a minimum of **1mm (0.040 inch)** clearance to the pulley mounting bracket.
7. Refer to Workshop Manual (GTR) Section 303-05 (86-10.03) to install the new idler pulley and FEAD belt.
