# **Dual Mass Flywheel (DMF)**

# **DMF- Checking Process**

# **DMF: Visual aid for diagnosis of thermal issues**

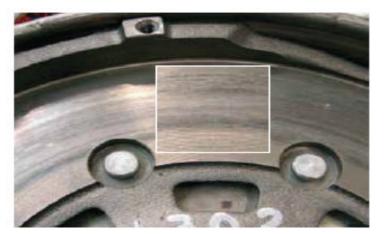
#### 9. Low thermal load

- · Friction surface slightly discoloured (gold/yellow)
- →No tarnish at the outer edges of the DMF or in the

rivet area

Thermal load

None

No remedial measures required

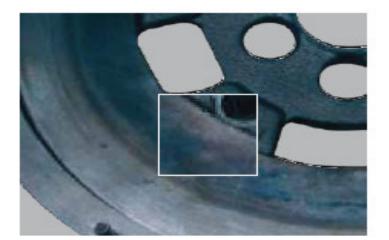
# 10. Moderate thermal load

- Friction surface discoloured blue due to temporary thermal load (220 °C)
- No discolouration in the rivet area

Discolouration of the friction surface is a normal occurrence during operation

None

No remedial measures required

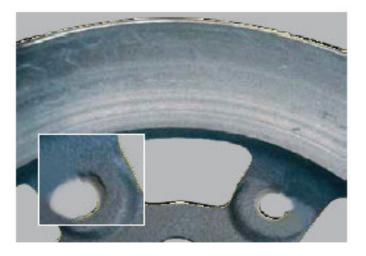
## 11. High thermal load

- Tarnish in rivet area and/ or at the outer diameter; no tarnish on the friction surface
- → The DMF was in continued operation after high thermal load had occurred

- High thermal load (280 °C)
   Effect
- Depending on the duration of the thermal load applied, the DMF may become defective

Replace DMF

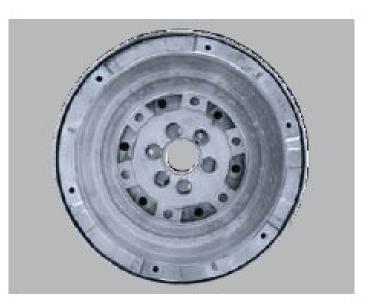
# 12. Very high thermal load

DMF discoloured blue/purple at the side or on the back and/or is visibly damaged, e.g. cracks

· Very high thermal load

DMF is defective

• Replace DMF
