A Guide to Retro-fitting the OEM Factory Supplied Rear Screen Entertainment System to a Discovery 3 HSE

Since 2008 model year Land Rover finally made the RSE system available to order for the Discovery 3, but only as a factory supplied option and at a cost of £2250. Strange really as this touch screen controlled rear entertainment system has been available since 2005 on both Range Rover and Sport models. Although Land Rover claims this cannot be retrofitted - it can!

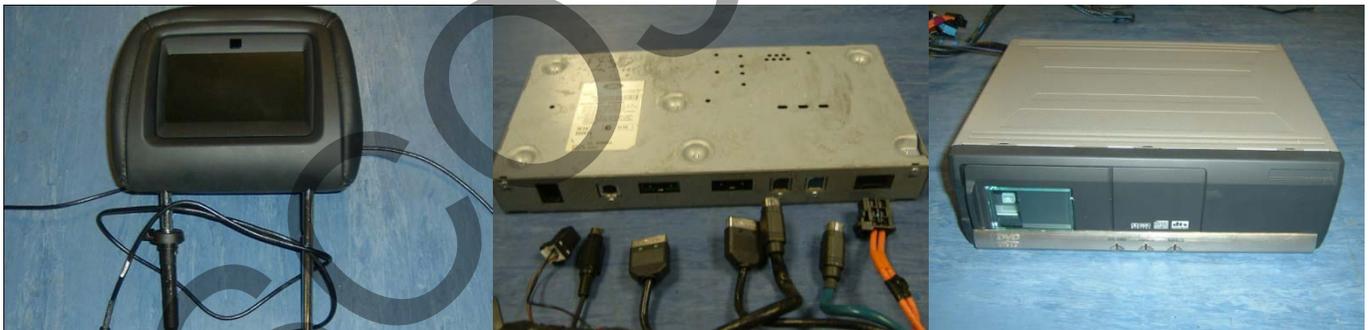
Parts List:

Pair of Headrests with OEM monitors installed including cables in LH stems.

RSE Module – YIL000053 / LR011330

DVD 6 Disc Changer – Region Specific so many part numbers!

AVIO Panel (Optional) - XVN500040

DVD Remote Control (Optional) – YUH50060

DVD Mounting Bracket – YIP500430

DVD Retainer Bracket – YIP500420

RSE Mounting Bracket – XQU500180

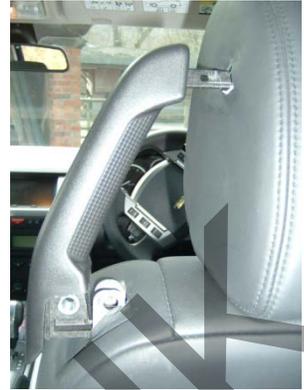
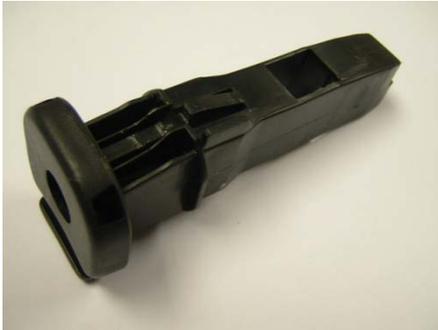
Removing the existing headrests is straight forward but requires the removal of the grab handles first. Prise off the cover to expose the single torx screw and once removed the grab handle can be pulled off horizontally. The top bolt that goes into the headrest itself is not fixed and comes away with the handle. When both handles have been removed the headrest can be raised by pressing the locking tab in the left hand headrest sleeve, the tabs are located under the leather but operate in the same way as in the second row, don't forget to depress the right hand sleeve locking tab at the point when the stem is nearly completely exposed.

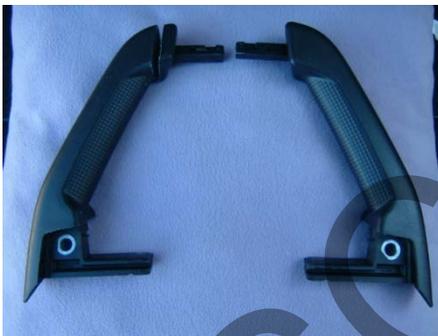
With the headrests out it is then necessary to remove the left hand sleeve which when you know how is again very easy. The sleeve locks into the metal seat frame by a small spring clip located on the opposite side to the locking tab. This can be pressed in using a flat screw driver at the same time pulling the sleeve up and out of the frame. If the new headrests with monitors already have a sleeve fitted, as supplied from the factory, then its time to feed the cable down through the back of the seat. For ease of access it helps to first move and raise the seat forward to be able to unclip the leather

in order to retrieve the cable end. If like me, your headrests don't have a new sleeve, then my tip is that as the connector plug on the end of the cable will not pass through the sleeve its far easier to cut the sleeve and feed the cable through it rather than cutting the cable and attempting a soldering job!

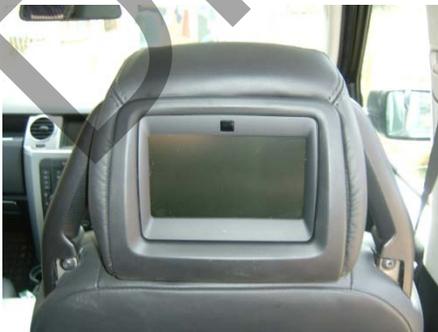
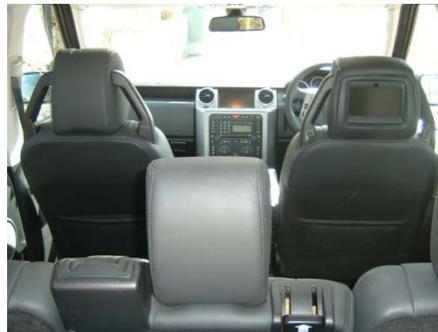
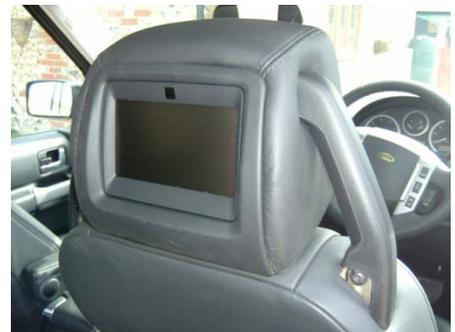
With the new headrest and sleeve fitted it's now necessary to modify the grab handles. The standard D3 headrests are approximately 180mm wide; Range Rover Sport headrests are approximately 230mm which are often used with after market screens. The factory supplied headrests with monitors are just 10mm wider at 240mm. Having seen other installations I decided that not only would I cut the bolt section off but to improve the appearance and give a more OEM feel I chose to cut a further 10mm or so and to square off the original angled edge. With all 4

handles modified they can be refitted and the torx bolt done up, this can be a bit of a challenge as each handle needs to be pressed against the headrest firmly in order for the torx screw to locate correctly.

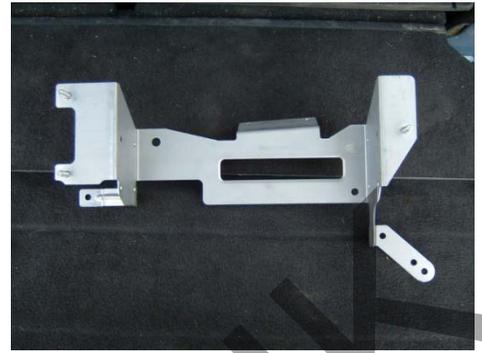
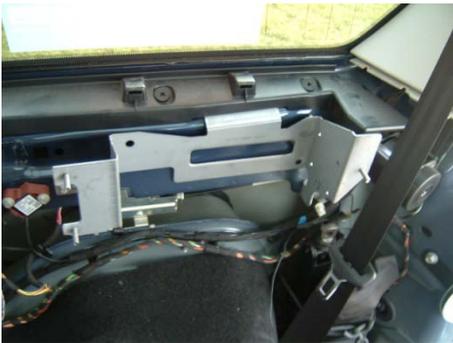
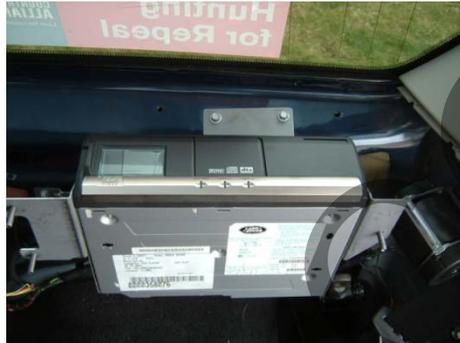
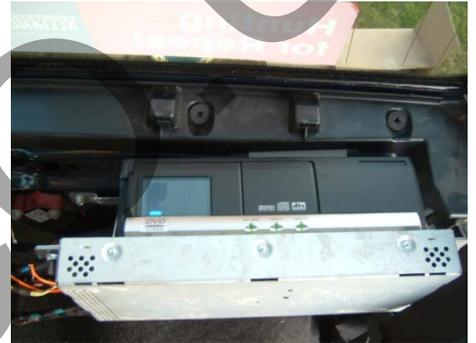
Both the DVD Changer & RSE modules fit behind the rear RH quarter panel and are easily secured into place when using the correct brackets which can be ordered for less than £30 through any Land Rover Parts Department.

I mounted the DVD bracket just to take the photo but it's a lot easier to secure the changer, with eight small screws, to the bracket BEFORE fitting it! The bracket is held in place by four machine threaded bolts and in my car (08MY) the holes were already predrilled and tapped in the body of the vehicle. The RSE module fixes to its own bracket again using four of the same small screws used for the changer. The RSE bracket then locates on the three threaded stems of the changer bracket and secured using 6mm locking nuts.

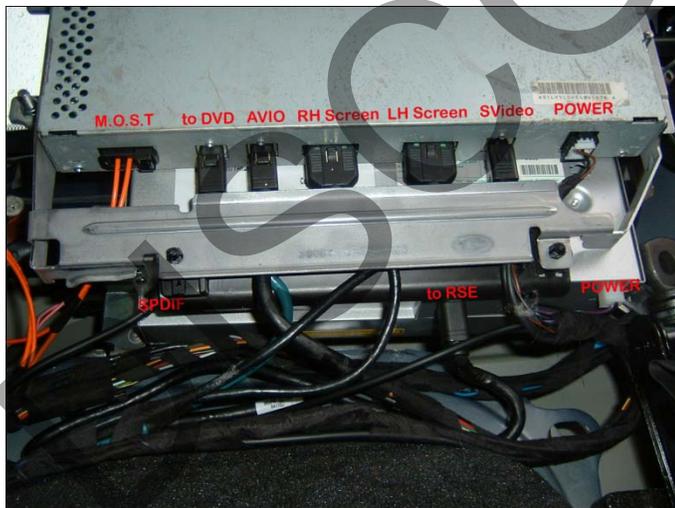
I have labelled in **Red** the 10 cable connections, 7 on the RSE and just 3 on the DVD Changer. Starting from left to right and excluding the two power connectors for now. First up is the M.O.S.T ring and for this you need a female socket extending into two male connectors, this will allow you to disconnect either the TMC or Phone M.O.S.T plug and insert it into the female socket and then install one of the male connectors back into either the TMC or Phone and the other into the RSE Module.

Next is the 13pin to 13pin Alpine lead, a shorter black cable, which connects to the DVD changer.

After this you have the optional AVIO (Audio Video Input Output) lead which connects to the AVIO panel located in the rear centre console under the air vents (assuming you have acquired one!)

The next two cables are self explanatory each going to their respective seat headrest monitor which on the RSE Module then just leaves the SVideo cable: This has a 4 pin plug that uses 2 pins to allow the input of the TV signal (if fitted) and the other two pins to output the DVD/TV signal via a single coax cable with a well documented green fakra connector on the other end that joins to the rear of the touch screen. The diagram to the right shows the pinout for the RSE socket. As I already have the TV tuner I didn't need to run this cable to the front screen, but if you need to, the factory loom containing this lead would follow the same path as the AVIO cable under the centre console and then continue on up behind the heater switches and radio before connecting to the touch screen. As an alternative it may be easier to route this down the right hand side of the car next to the other wiring looms.

On the DVD Changer the first cable from the left is the SPDIF (Toslink) Fibre Optic Cable which needs to be connected to the Logic 7 Amp under the right hand seat – without this cable the DVD audio in 5.1 stereo cannot be heard through the car speakers. This has no effect on the audio in the rear headphone sockets which receive its sound via the M.O.S.T ring. The next cable is the other end of the 13 pin Alpine cable that connects the DVD to the RSE module, leaving just the power cables for both RSE & DVD.

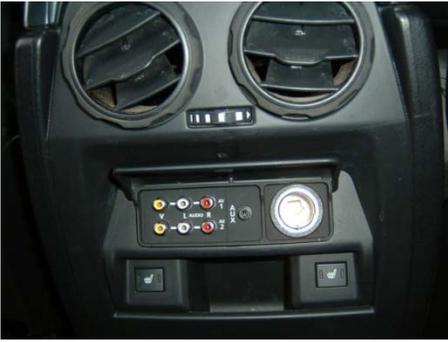
Getting the AVIO cable up to the panel is more of a challenge as you really need the additional short blue Alpine extension cable and requires the removal of the centre console trim around the gear shift and cubby box in order that this cable can be routed to an area near the EPB switch, it can then connect into the main blue AVIO cable which needs to run from the RSE module in the rear up to the EPB area of the centre console. Unfortunately with the cubby box removed there is no direct route the floor due to the “secret” cup holders! I found that removing the two torx screws behind the small grills on the lower rear side sections of the console allows the

complete console to be lifted which makes life so much easier not only to run the main AVIO cable but also to get the LH monitor cable across under the carpet to an area near the Navigation Computer. I did complete this part of the project just because I wanted the full OEM package but unless you plan to use these additional inputs for either another portable dvd player or a games console on a regular basis then you could skip this especially as AV1 & AV2 can only be viewed on the headrest monitors and not on the front touch screen.

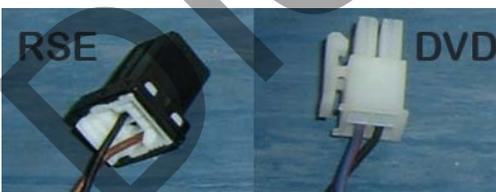
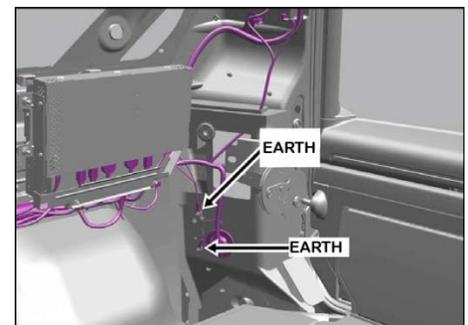
The RSE module has an 8 pin connector for its power feed and the DVD a 4 pin connector. Both connector plugs only use 2 pins each, a 12v + and an earth. The two earth wires can be linked together and

should terminate on one of the earth posts at the rear (see diagram right). In order to ensure both units receive the correct power supply from the ICE system it is NOT recommended just to tap into the nearest power supply from other modules such as the TMC, Phone or TV units if fitted!! The correct feeds are as follows:

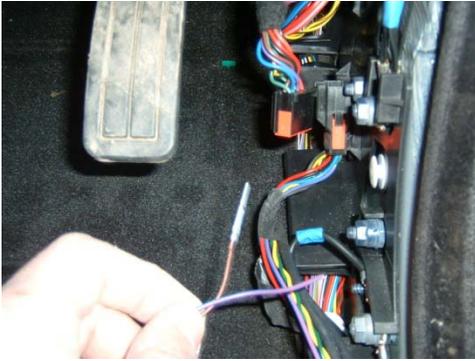
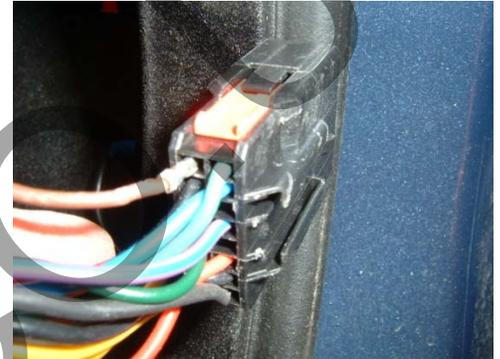
After closely studying the wiring diagrams it became clear that the RSE Module & DVD Changer should take their power from the ICE navigation loom connector C2247/C2249 located in the front right footwell. This is a 16 pin black/red connector, C2249 (the lower section) is part of the navigation loom and contains male pins that join into the female plug socket C2247 from where the wires then go on up and back to the fuse box area.

I used the correct colour coded wires – Brown for the RSE which goes to Pin 1 and Purple/Blue for the DVD Changer, which needs to join to the cable from C2249 Pin 12, that then goes on to the navigation computer. Although you could join this purple/blue wire further back near the ‘B’ post I decided that as I had to run the

RSE brown power wire to the footwell I would join the DVD changer wire there too plus it was easier to identify and locate the correct Pin 12 wire! My brown wire already had the correct male pin attached so it was a simple process to install it into the C2249 connector in the vacant Pin 1 chamber. On my vehicle and having already checked before I started, I was extremely pleased to find that the corresponding Pin 1 brown wire was already present in the female C2247 socket – Using this feed is important as it is the correct rated fuse (No. 57) and ICE switched supply! Connecting the DVD wire to the existing purple/blue supply from Pin 12 can be achieved in a number of ways, I chose to strip away a small section and solder it but interestingly when I stripped the cables from my originally salvaged loom most “joints” were just twisted together and insulated with tape!!!!

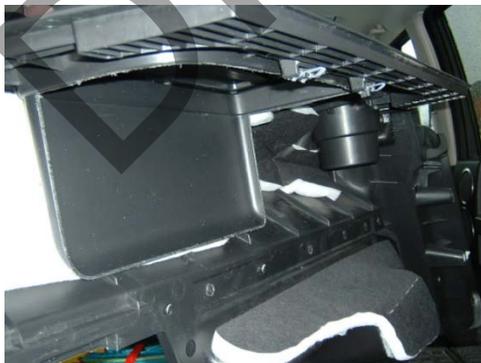
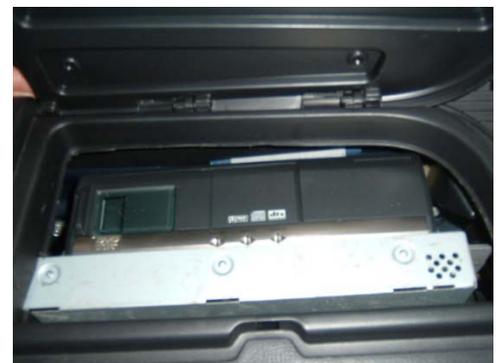
With the DVD & RSE Modules fitted in their correct location you have two choices relating to refitting the rear quarter panel. The first is to pay around £120 for a brand new panel with the correct section beneath the hinged cubby box lid (Part No. ESJ501580PVJ) or the second more cost effective option is to cut away most of the box itself and re-use the original panel which for me made much more

sense. Just pay close attention to the left hand side of the RSE module which needs a small additional piece removed in order for the panel to locate correctly as it sits higher than the DVD but when the hinged lid is closed you would never know they were there!

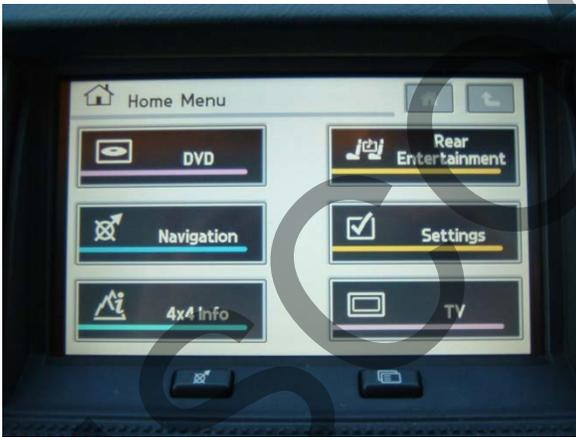
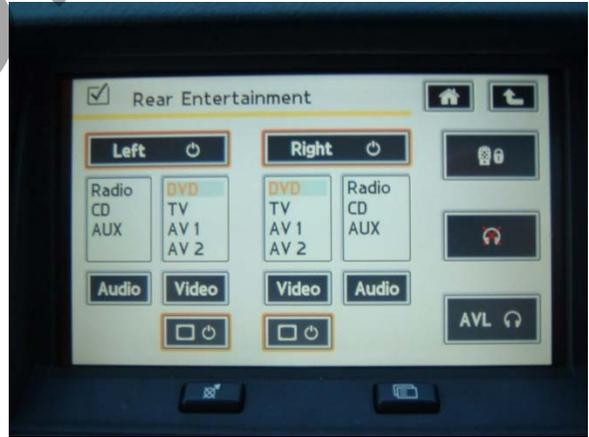
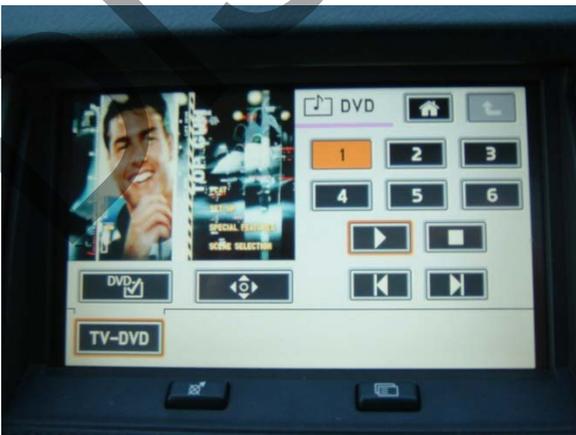
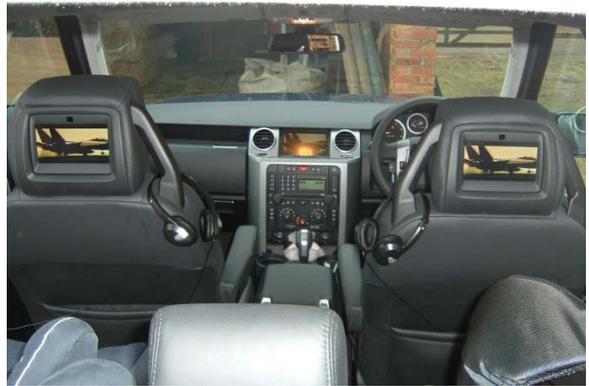
Plugging in his box of tricks to read the CCF it is then necessary to switch on the options to tell the car it now has the RSE, DVD and AVIO fitted. The picture to the right shows the correct options we selected for my car. This is just a five minute job and when complete you should end up with the new options on the home screen a sample of which are below!

Rear Seat Entertainment Interface Module Fitted	Yes (100%)
Rear Seat Entertainment DVD Player Fitted	DVD/Player 1st Med (30%)
Rear Seat Entertainment DVD Audio Configuration	DVD Audio compatible (80%)
Clear Screen Reset	Yes (100%)
Rear Seat Entertainment Right Hand Display Module	Fitted (30%)
Rear Seat Entertainment Left Hand Display Module	Fitted (30%)
Rear Seat Entertainment Additional Display 3	Not Fitted (100%)
Rear Seat Entertainment Additional Display 4	Not Fitted (100%)
Rear Seat Entertainment Additional Display 5	Not Fitted (100%)
Rear Seat Entertainment Error	No (100%)
Rear Seat Entertainment Reserved	Not Fitted (100%)
Headphone Socket Fitted	Rear headrest sockets (27%)
Headphone Socket 1 In Fitted	Headphone 1st Med (27%)
Headphone Socket 2 In Fitted	Headphone 2nd Med (27%)
Headphone Socket 3 In Fitted	Headphone 3rd Med (24%)
Headphone Socket 4 In Fitted	Headphone 4th Med (24%)
Audio Visual Fitted	Unfitted (0%)

Audio Visual Audio Input	Not Fitted (100%)
Audio Visual Audio Output	Not Fitted (100%)
Audio Visual Auxiliary Input	Installed (70%)
Audio Visual DVD/CD (Front/Rear)	No (100%)
Audio Visual USB 1	No (100%)
Audio Visual USB 2	Not Fitted (100%)
Audio Visual Video Input	Fitted (30%)
Audio Visual Video Output	Fitted (30%)
Front Auxiliary	Disabled (100%)
Installation Type	As Supplied (0%)
Installation Weather Type	Resistant to 1st Med (60%)
Vehicle / Companion Camera Clocking Station	Companion not Med (100%)
Vehicle / Companion Camera 1	Not Fitted (100%)
Vehicle / Companion Camera 2	Not Fitted (100%)
Vehicle / Companion Camera 3	Not Fitted (100%)
Vehicle / Companion Camera 4	Not Fitted (100%)
Vehicle / Companion Camera 5	Not Fitted (100%)
Companion Camera Supplier Test Mode	No (100%)
Vehicle / Companion Camera Priority	Companion Supplier R3 (100%)
Vehicle / Companion Cam Double Exposure	Unfitted (100%)
Companion Cam Drive	No (100%)

Parking Camera Fitted	No parking camera Med (100%)
Bluetooth	Bluetooth enabled (30%)

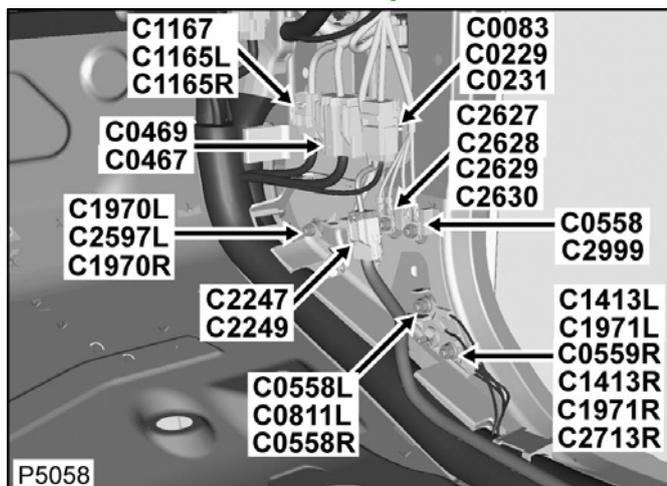
Connector: **C2249**

Harness: **ICE/NAVIGATION HARNESS**

Description: **ICE harness to instrument panel harness**

Location: **Base of RH 'A' post**

CAV	TERMINAL	CSA	COL	CCT	DESTN
1	YPJ800250	0.5D	N	425	C2116
2	YPJ800250	0.5D	B	148	S/JOINT SJ134
3	YPJ800250	0.75D	R	502	S/JOINT SJ299
4	YPJ800250	0.5D	G	148	C2114
5	YPJ800250	0.5D	Y	148	C2114
8	YPJ800250	MQD	Y	148	C2114
9	YPJ800250	MQD	G	148	C2114
10	YPJ800250	0.75D	U	420	S/JOINT SJ530
12	YPJ800250	0.75D	PU	701	C2114
12	YPJ800250	0.75D	PU	703	S/JOINT SJ138
12	YPJ800250	0.75D	PU	702	C2832
14	YPJ800250	MQE	R	704	C0395

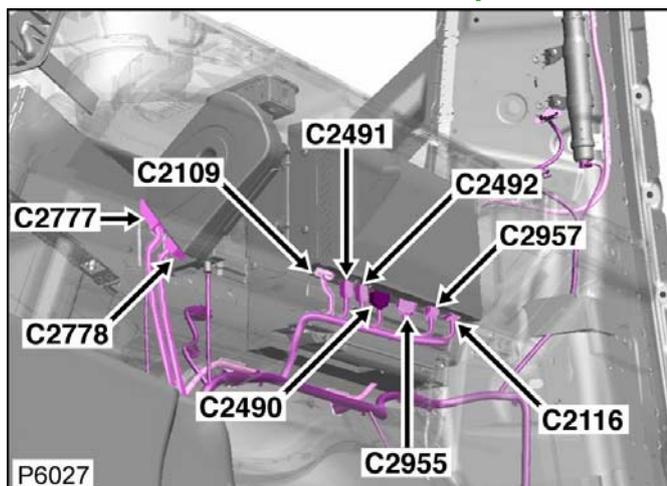
Connector: **C2116**

Description: **Module-Rear seat-entertainment**

Location: **Behind RH rear trim panel**

CAV	TERMINAL	CSA	COL	CCT	DESTN
1	YPL10036	0.5D	N	425	C2249
3	YPL10036	0.5D	B	425	S/JOINT SJ700

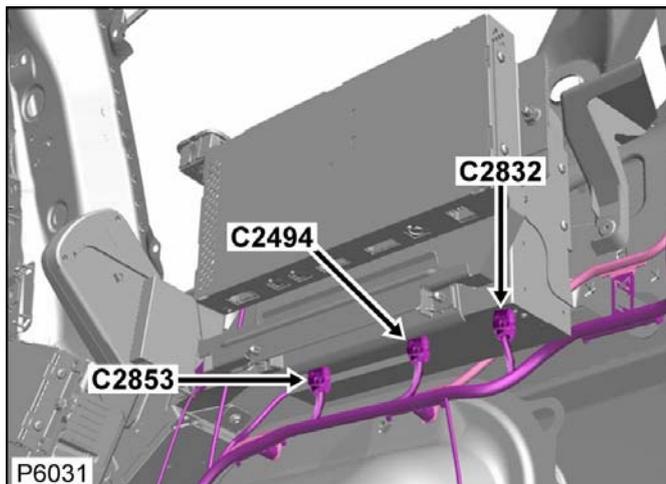
Connector: **C2832**

Description: **Module-DVD**

Location: **Behind RH rear trim panel**

CAV	TERMINAL	CSA	COL	CCT	DESTN
2	YPL102630	0.5D	B	425	S/JOINT SJ700
4	YPL102630	0.75D	PU	703	S/JOINT SJ138
4	YPL102630	0.75D	PU	702	C2249
