TECHNICAL BULLETIN

No: LTB00328 (ISSUE 1)
18 JANUARY 2011

RANGE ROVER

Rear Door Window Regulator - Lower Level Service Repair

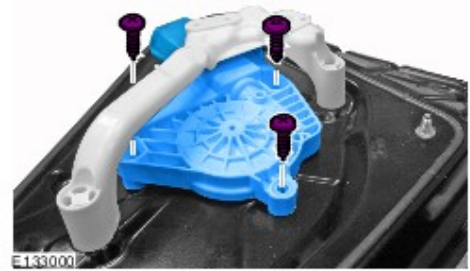
Figure 3

1. Remove the three screws. (Figure 3)

4. Remove the trim supporting bracket: (Figure 5)
 - Remove the three screws.
5. Remove the rear window regulator motor.
6. Install the new window regulator motor: (Figure 3)
 - Install the three screws.
7. Install the trim supporting bracket: (Figure 5)
 - Install the three screws.
8. Refer to Workshop Manual, section 501-11, and install the window regulator.
9. Verify window operation.
