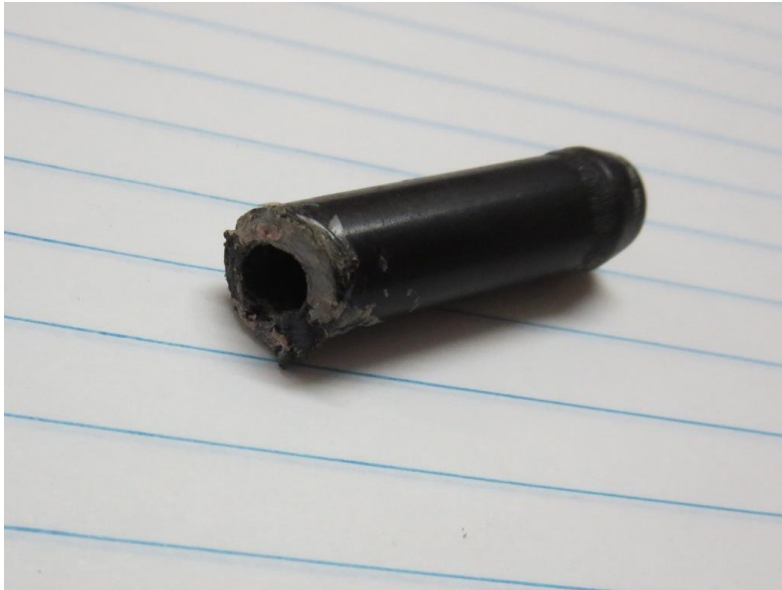
1. Broken fitting. 5mm to 6.5mm tapered I.D.

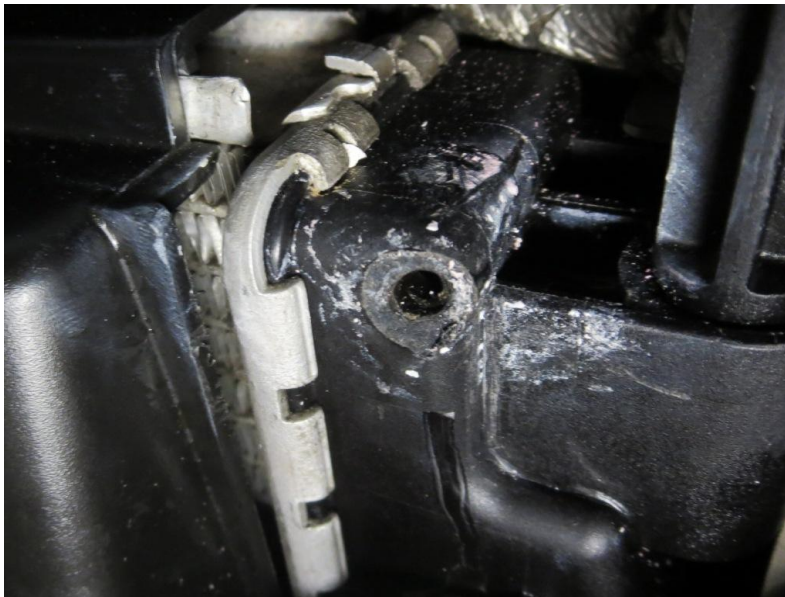
2. The hole left in the radiator was 4mm diameter

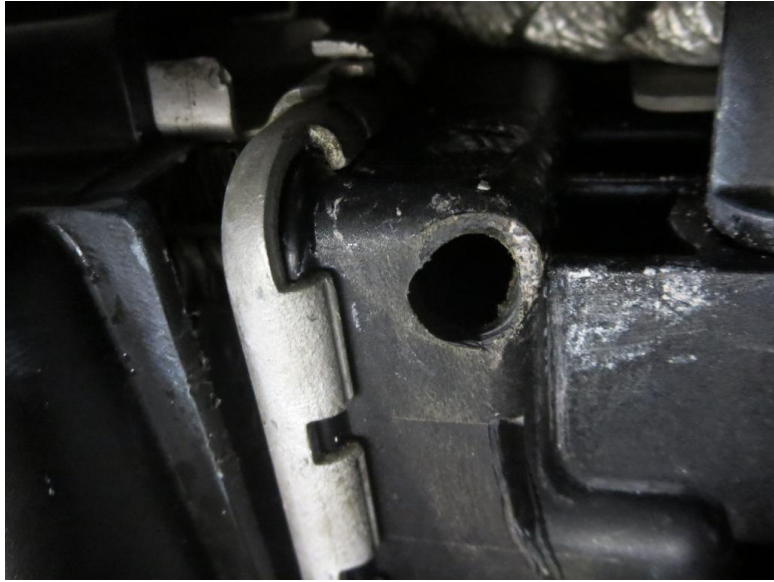
4. Drilled in stages to 11/32" to suit a 1/8" BSPP tap

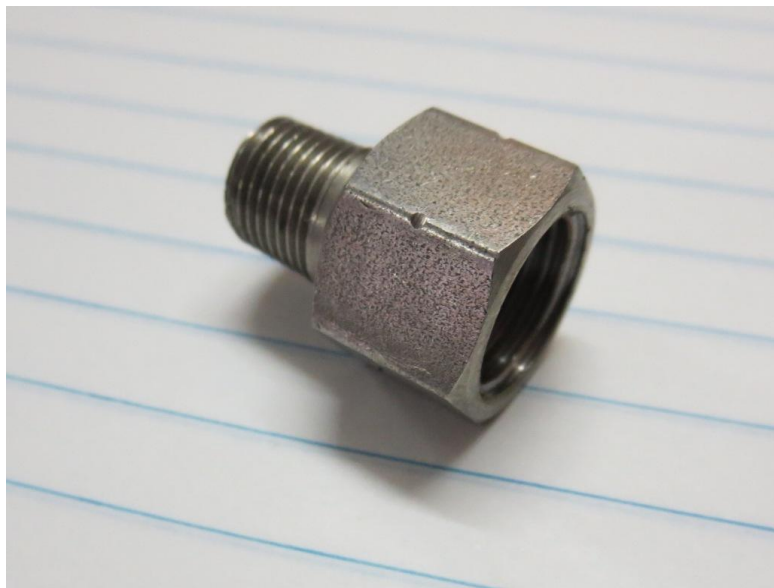
5. 1/4" BSP female to 1/8" BSP male stainless steel reducer

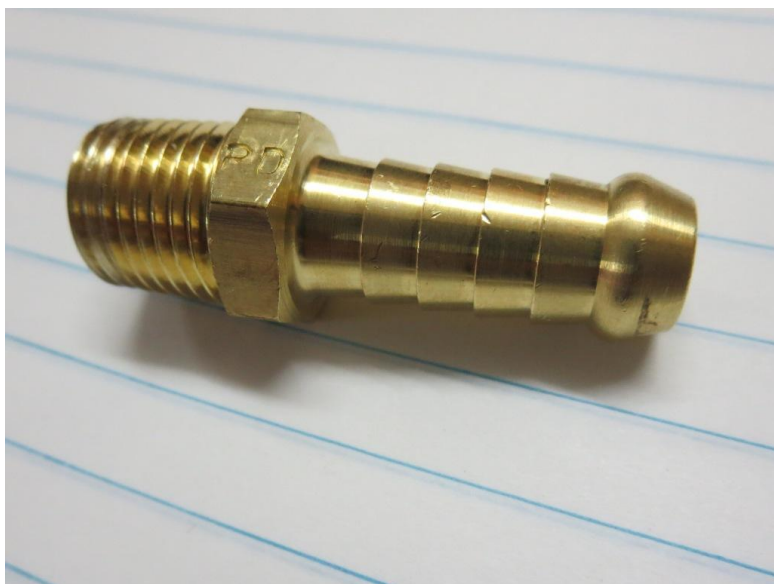
6. 3/8" x 1/4" BSP brass hose tail

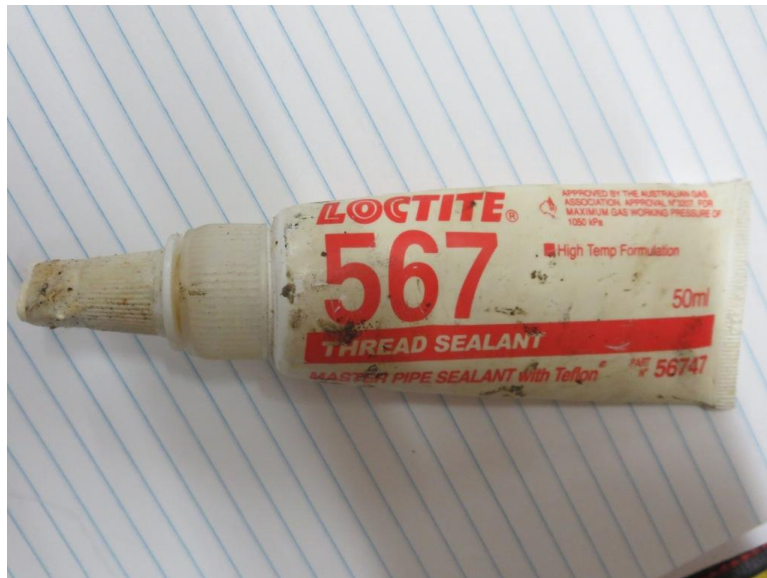
7. 'LOCTITE' 567 thread sealant

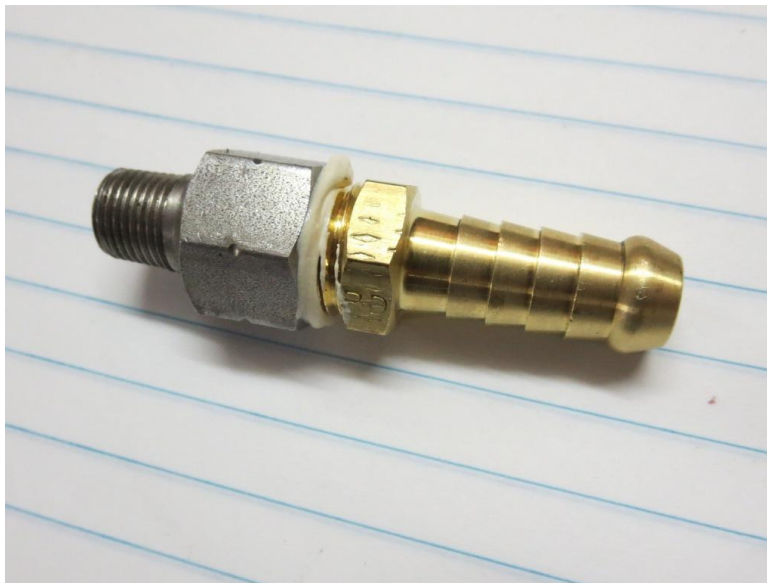
8. Assembled fittings

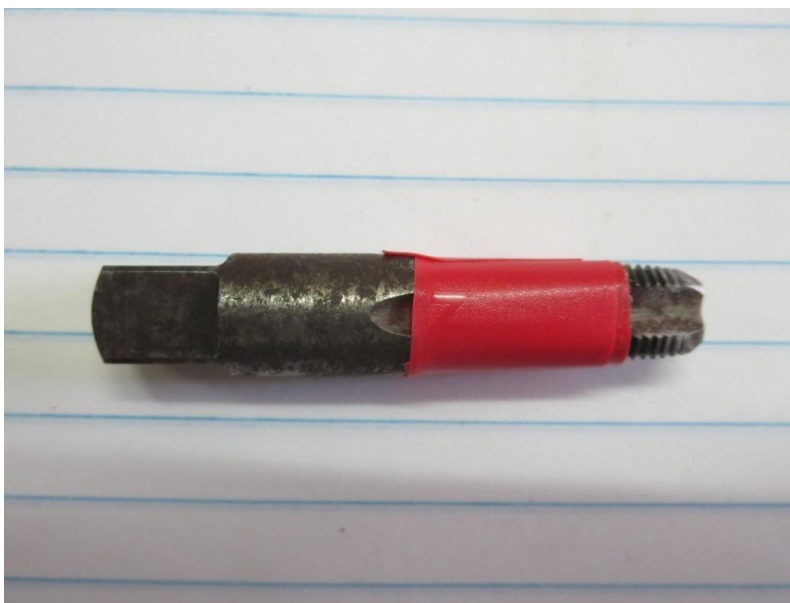
9. 1/8" BSPP tap showing approximate tapping depth from end to tape

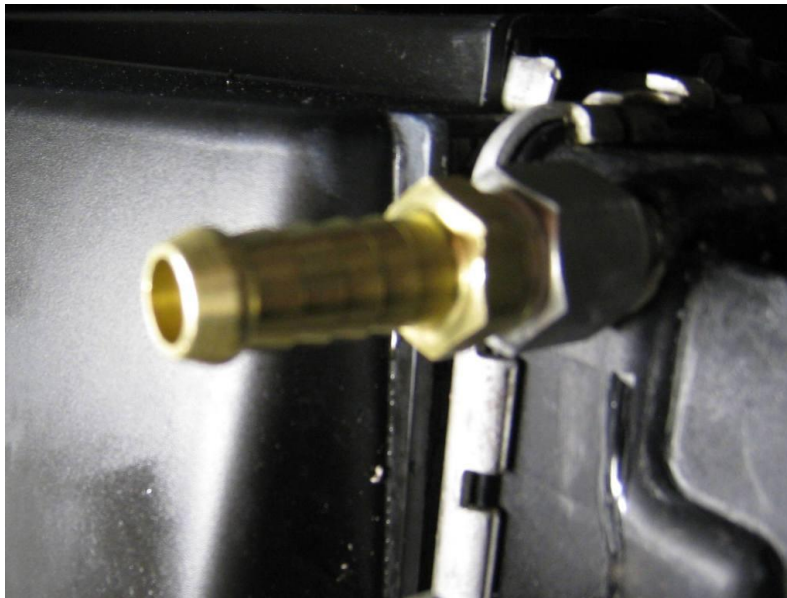
10. Fitting screwed in place with thread sealant

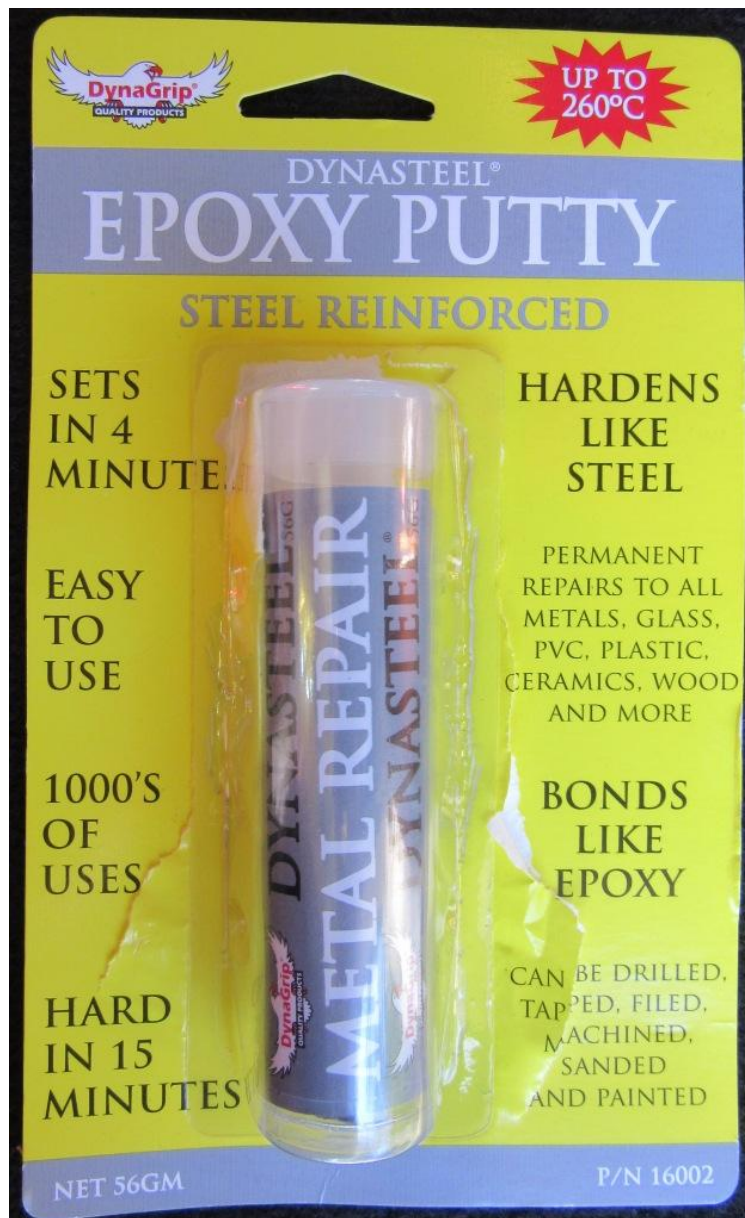
11. 'Dynasteel' Epoxy Putty
