# TECHNICAL BULLETIN

No: LTB00218  
Issue: 1  
Date: 20 MAY 2010

## Water Leak Into Footwell From Roof Opening Panel Drain Tube

LR3 (LA)

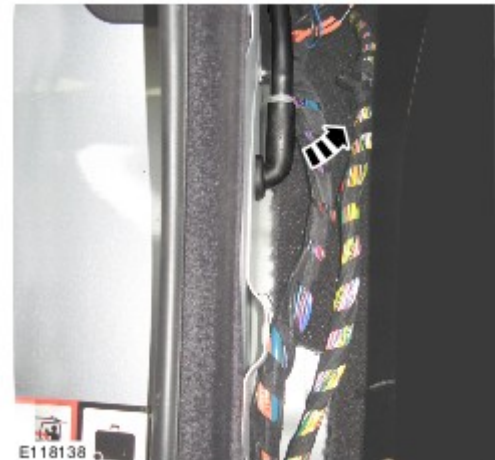
Figure 1

1. Refer to Workshop Manual (GTR) section 501-05, *Interior Trim and Ornamentation* (76.13.34), and remove the affected side's (LH or RH) C-Pillar Upper Trim Panel.
2. Release the rear door weatherstrip for access.
3. Release the roof opening panel drain tube from the lower drain grommet. (Figure 1)
4. Remove the drain tube connector from the new drain tube (EEH500120) and discard the new drain tube.
5. Trim **25mm (1.0 in)** from the end of the existing roof opening panel drain tube. (Figure 2)
6. Install the new drain tube connector into the existing roof opening panel drain tube.
7. Install the roof opening panel drain tube into the lower drain grommet.
8. Install the rear door weatherstrip.
9. Refer to Workshop Manual (GTR) section 501-05, *Interior Trim and Ornamentation* (76.13.34), and install the C-Pillar Upper Trim Panel.

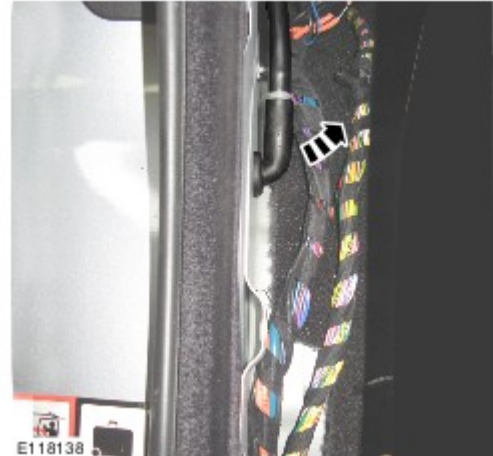
Figure 3

1. Refer to Workshop Manual (GTR) section 501-05, *Interior Trim and Ornamentation (76.13.22)*, and remove the affected side's (LH or RH) Load Space Trim Panel.
2. Release the rear door weatherstrip for access.
3. Release the roof opening panel drain tube from the lower drain grommet. (Figure 3)
4. Remove the drain tube connector from the new drain tube (**EEH500120**) and discard the new drain tube.
5. Trim **25mm (1.0 in)** from the end of the existing roof opening panel drain tube. (Figure 4)
6. Install the new drain tube connector into the existing roof opening panel drain tube.
7. Install the roof opening panel drain tube into the lower drain grommet.
8. Install the rear door weatherstrip.
9. Refer to Workshop Manual (GTR) section 501-05, *Interior Trim and Ornamentation (76.13.22)*, and install the Load Space Trim Panel.
