# **Dual Mass Flywheel (DMF)**

# **DMF- Checking Process**

# **DMF: Visual aid for diagnosis of thermal issues**

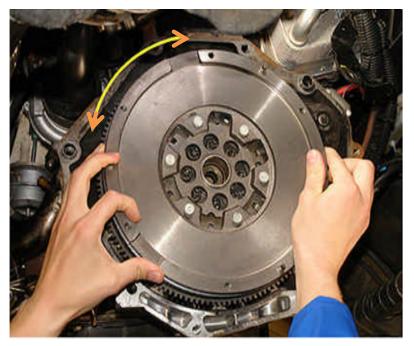
Pic 1

# Rotate the secondary mass in both directions by hand (Pic 1), you should feel spring resistance in each direction.

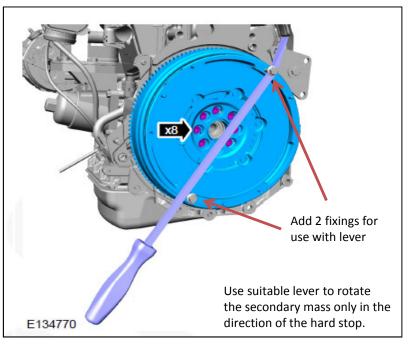
# If spring resistance can't be felt in both directions rotate the secondary mass WITH FORCE using a suitable lever but only in the direction where the hard stop was felt rather than spring resistance (Pic 2).

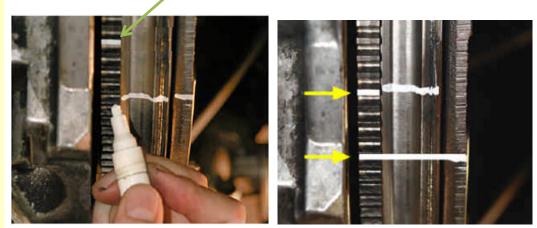
Pic 2

3. Clearly mark the position of the secondary flywheel and the ring gear with a white pen using a vertical line (Pic 2)
4. Now rotate the secondary flywheel anticlockwise until spring resistance can be felt
