RECALL ACTION

Recall Action
Number: P017

Brake Vacuum Assistance System	Publication No.:	P017
	Model:	Discovery 3/LR3
	Model Year:	2006-2009
	VIN Range:	LA367110 – LA513325
	Model:	Range Rover Sport
	Model Year:	2006-2009
	VIN Range:	LS929086 – LS999999 LS100000 – LS215618
	Date of Issue:	22 nd September 2009

RE: Brake Vacuum Assistance System

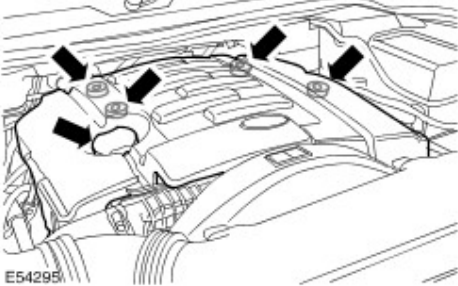
<p>E54295</p>
Fig. 1		
3	<p>Remove the fuel injector sound proofing (see Fig. 2).</p>

To avoid dirt or contamination entering the brake vacuum system ensure that prior to disconnection of the brake vacuum pipe and during the non return valve replacement the area around the brake vacuum pump is clean and clear of any debris.</p> <p>Pump the brake pedal until the brake vacuum assistance is exhausted.</p>	
2	<p>Remove the engine cover (see Fig. 1).</p> <ul style="list-style-type: none"> Remove the oil filler cap. Release the 4 clips.

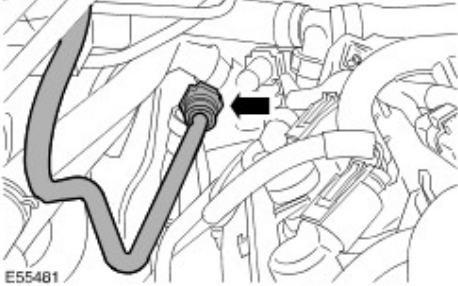
<p>E55461</p>
Fig. 3		
5	<p>CAUTION:

Always plug any open connections to prevent contamination.</p> <p>Disconnect the brake booster vacuum line from the brake vacuum pump (see Fig. 3).</p>

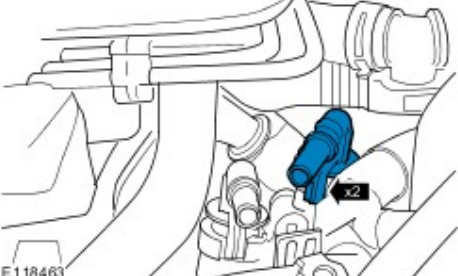
<p>E118463</p>

Failure to follow this instruction may cause damage to the vehicle.</p> <p>Remove and discard the brake vacuum pump upper inlet valve spigot (see Fig. 4).</p> <ul style="list-style-type: none"> Release the 2 clips.

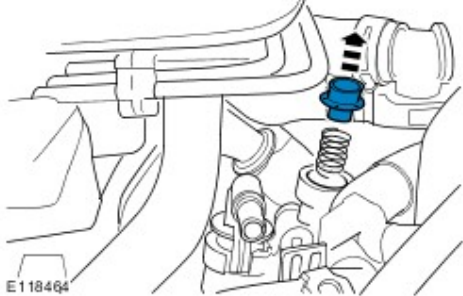
6	Remove and discard the brake vacuum pump inlet valve spring, ball and washer (see Fig. 5).	Fig. 4

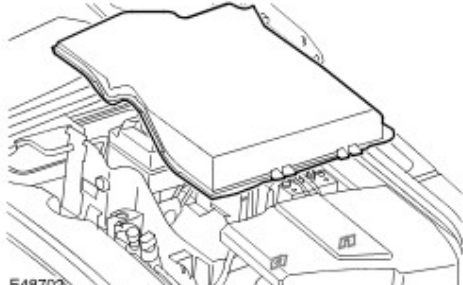
E118464
7	Remove the auxiliary battery cover. <ul style="list-style-type: none"> Release the 2 clips (see Fig. 6). 	Fig. 5

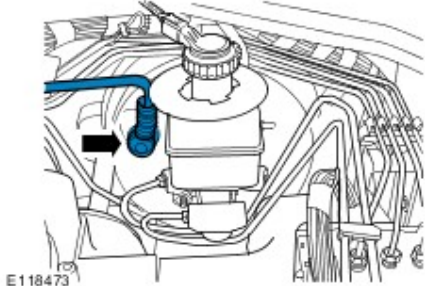
E118473
		Fig. 7
	Install	
9	CAUTION:

E48702
8	Disconnect the brake booster vacuum hose from the brake booster (see Fig. 7). <ul style="list-style-type: none"> Check for presence of oil in one way valve. If no oil presence in the one way valve, carry out steps 9 to 18 and release the vehicle. If oil is present in the one way valve, carry out steps 9 to 33. 	Fig. 6

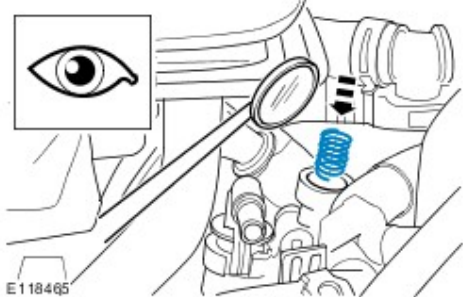
If new components are damaged when installing a new valve kit must be used. Install the brake vacuum pump inlet valve spring (see Fig. 8).	Fig. 8

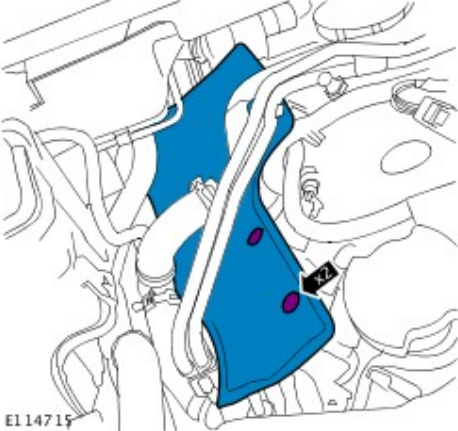
Fig. 13
15	Install the engine cover.	
16	Connect the brake booster vacuum hose.	
17	Install the cover(see Fig. 14).

14	Install the injector sound proofing (see Fig. 13).

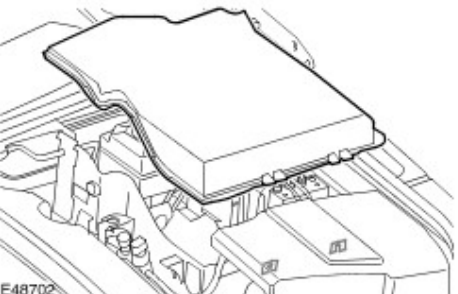
Fig. 15
21	If installed, remove the auxiliary battery.	
22	Release the anti-lock brake system modulator (see Fig. 16). <ul style="list-style-type: none"> • Remove the three nuts. • Release the brake tubes from the clip.

Fig. 14
18	Start engine and check the brake booster operation.	
Check for oil in the brake servo and master cylinder		
All vehicles		
19	Pump the brake pedal until the brake vacuum assistance is exhausted.	
20	Remove the auxiliary battery cover (see Fig. 15). <ul style="list-style-type: none"> • Release the two clips.
