Gearbox selector lever replacement

Thanks to Disco_Mikey, EdF and Robbie from the Disco3 forum (www.disco3.co.uk)

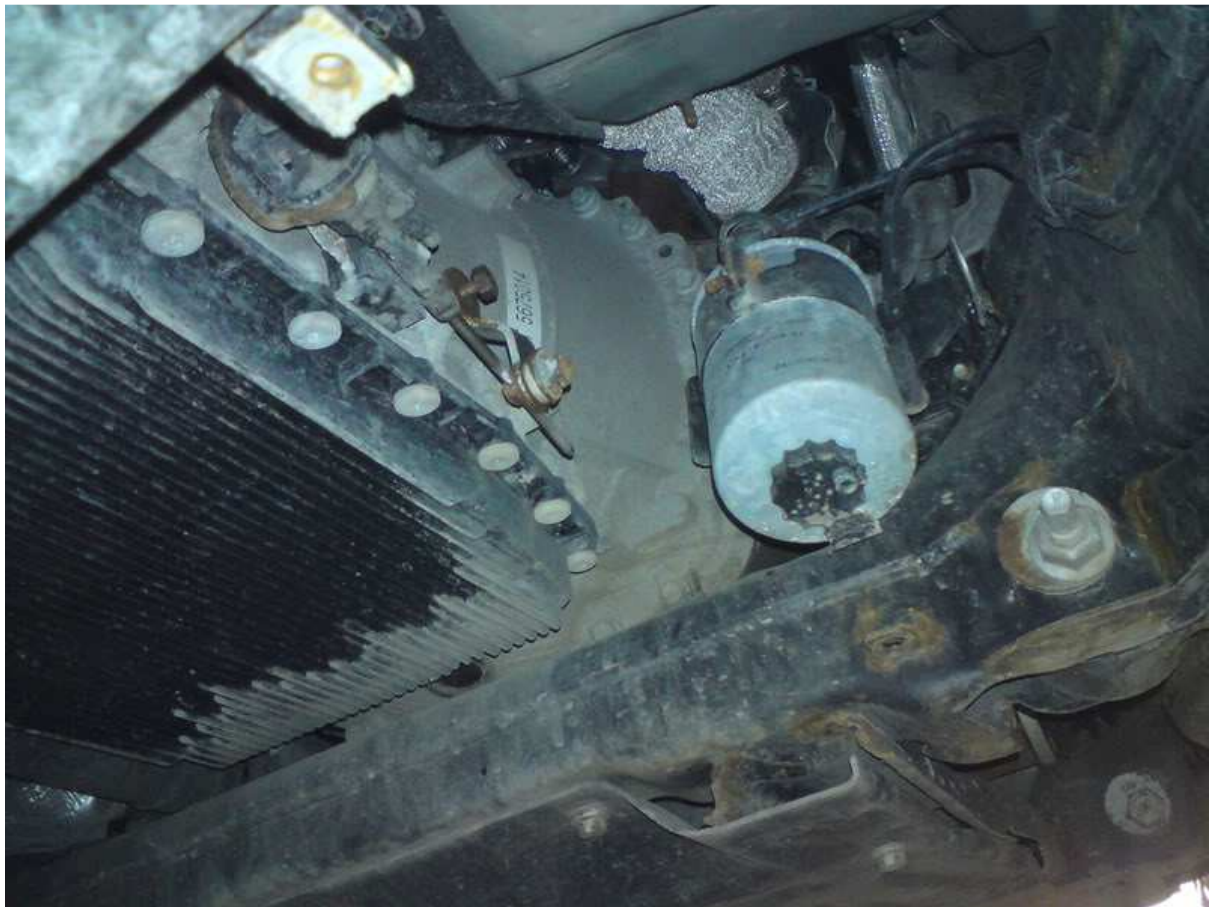
Start by putting the vehicle in park, and applying handbrake. Then get underneath and remove the g/box under tray, held on by 6x 10mm bolts. Mark the selector cable position with paint or similar to avoid having to readjust the cable.

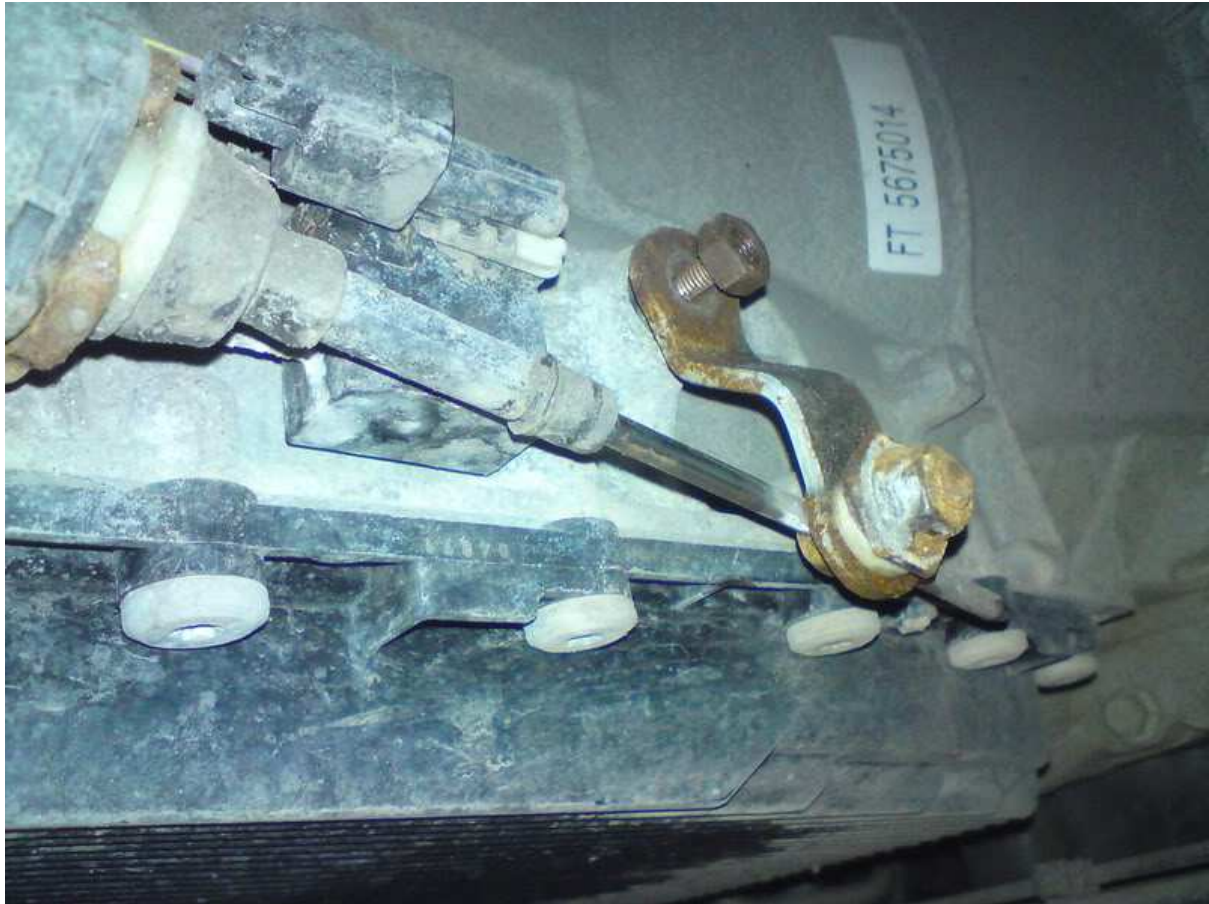
Locate selector lever and remove the top nut. It is important that the top one is undone first, otherwise you risk twisting the shuttle valve out of the valve block, and requiring the sump to be removed and your gearbox internals stripped

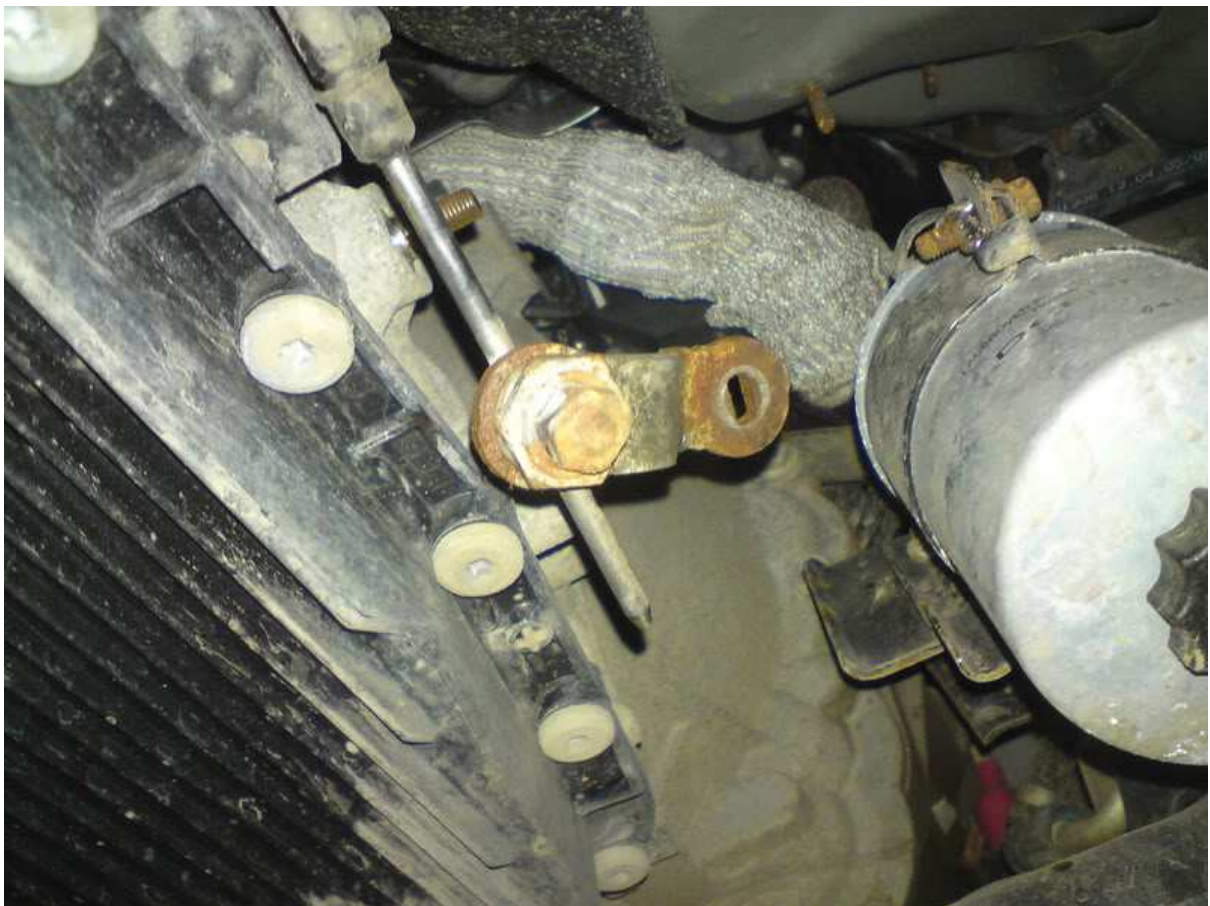
Before removing the top nut completely, hold the metal part with a 21mm spanner, and undo the lower 13mm nut securing the cable to pivot arm. Once it's loose, remove the top part from the gearbox and then remove the lever from the selector cable.

The bolt will probably be seized onto the cable, I have found the best way is to hit it off with the handle of a ratchet or small hammer. WD40 also helps.

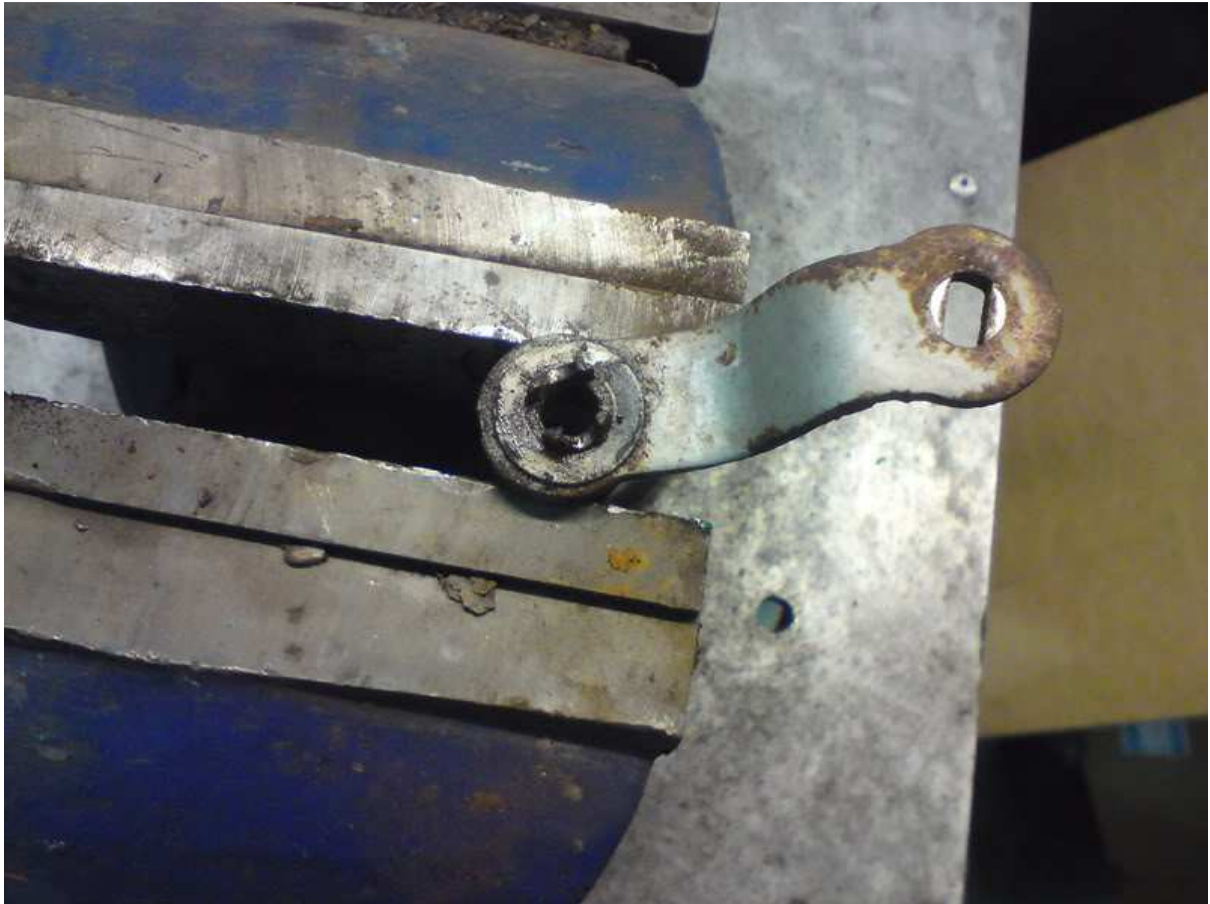
If you are just going to clean up the bush, you may even manage to leave the bolt part on the cable and remove the rest of it to a vice.

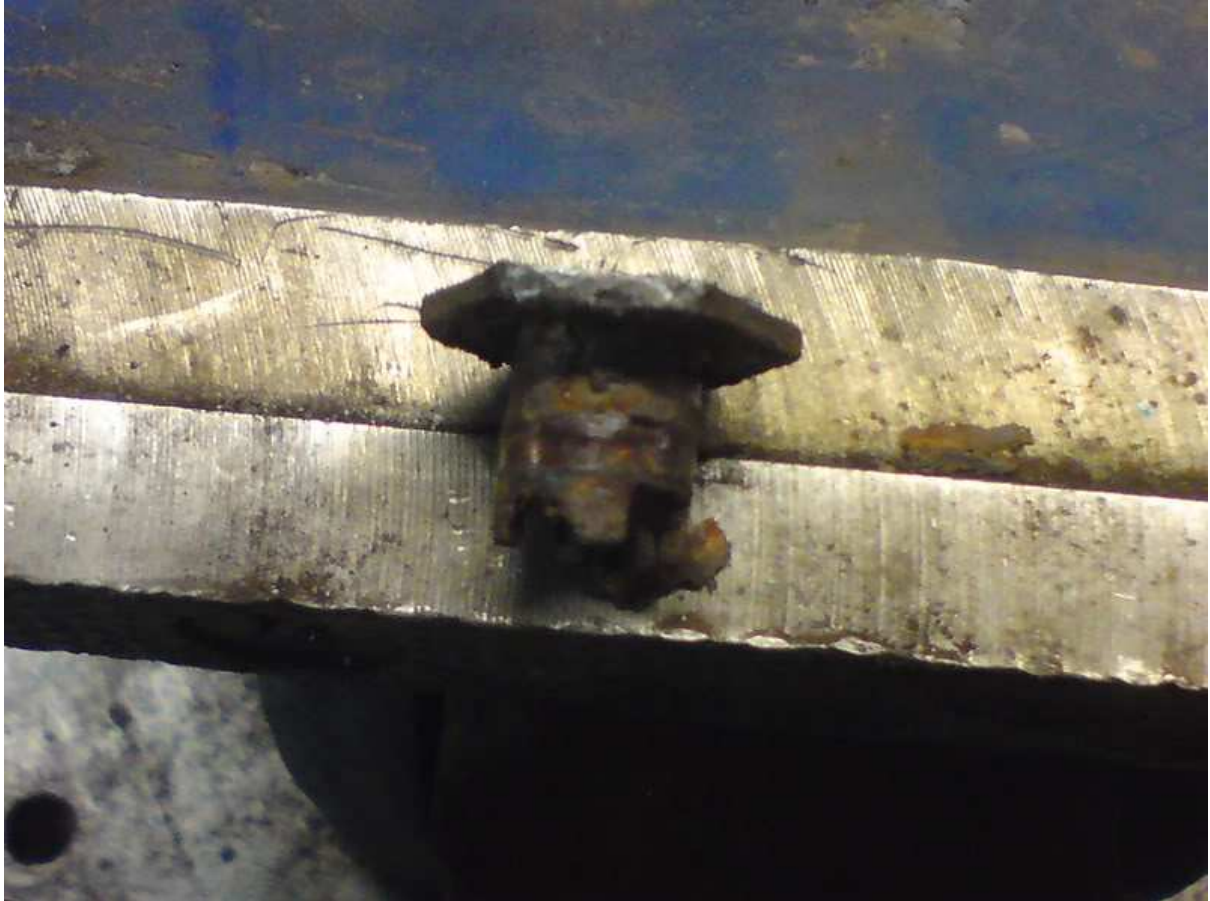
Hold the hex part of the metal insert and twist it and apply pressure upwards to remove the plastic bush from the metal insert. Once removed, bin the arm, and you are left with the bush.

As you can see, moisture has got into the mechanism and rusted the bush, swelling it up and causing excess friction that eventually means that the selector mechanism will seize.

Clean up the bush with emery paper or a wire wheel on a bench grinder or similar until it's all clean again. Alternatively, just replace it.

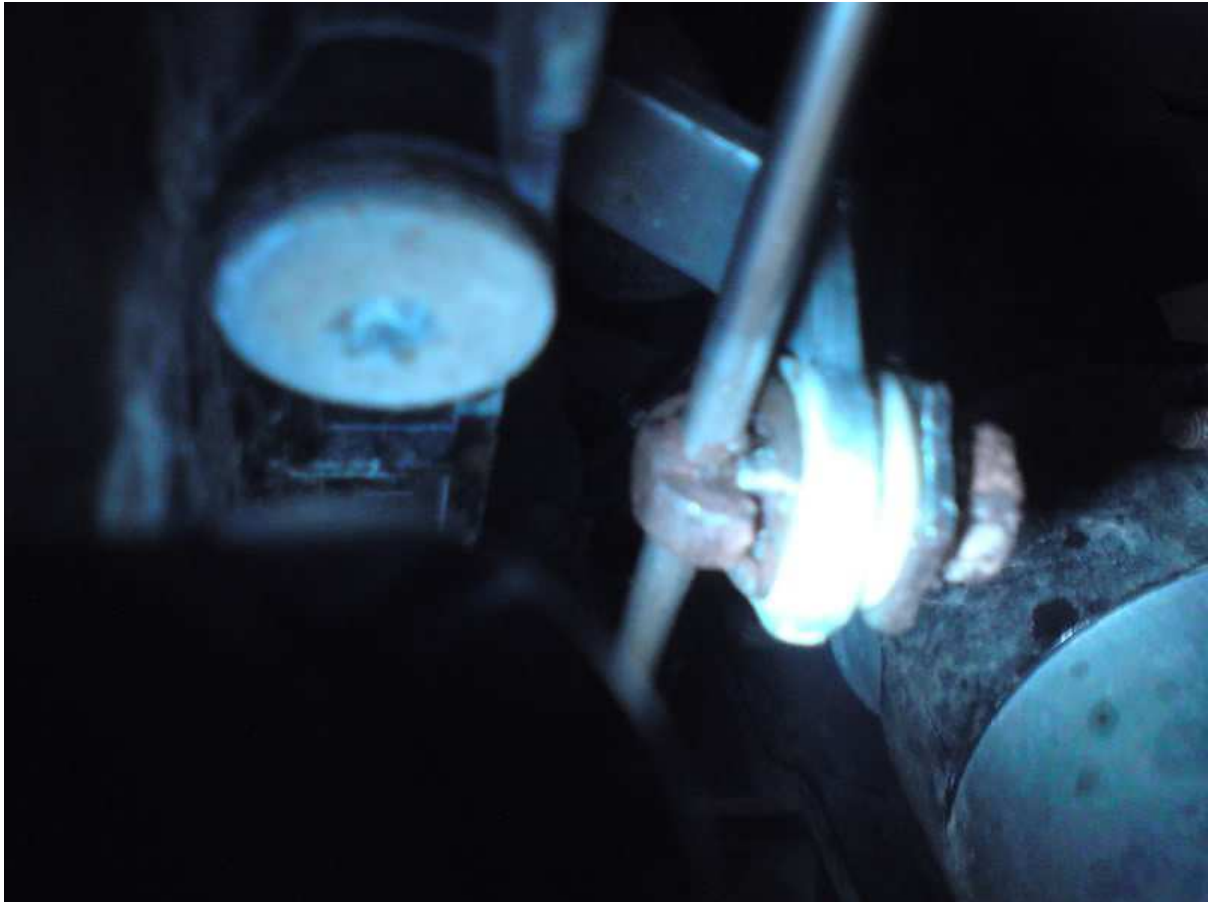
The bush has a square section and a smaller rounded section. The square part of it holds the head of the bolt in place, and the smaller part clamps the cable in place. It is vital again that these are correct otherwise you risk bending the cable and breaking the insert. Grease the bush and place into new arm, refit to selector cable and fit both 13mm nuts loosely, ensuring bolt is lined up correctly.

Tighten up lower nut first; using your paint marks to line up correctly. Once tight, move onto the upper one and tighten up. Torque settings are 10-12Nm. Always tighten up the lower nut first before the upper
