Front ARB Bush replacement with pictures LR015339

The project today was to replace the front Anti Roll Bar rubber bushes, which, having completed 116000 miles were ready for swapping. They've not done too badly - the knocking was only on the roughest of surfaces, and there were no spacers fitted.

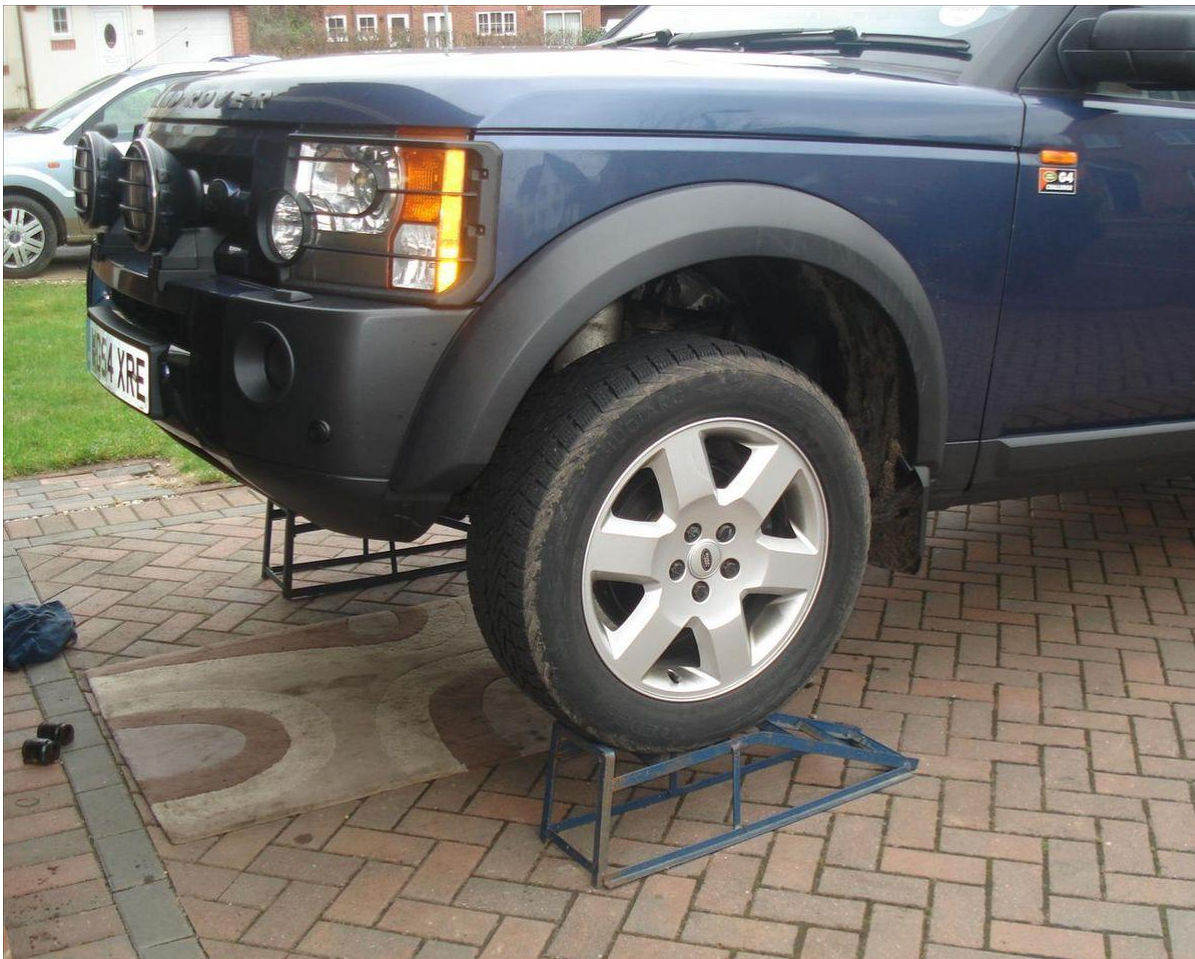
I raised the front of the Disco with ramps which gave enough room to work (with the suspension in off road height) , and there was no need to remove the wheels. As long as both front wheels are level there will be no torsion on the anti roll bar, so you can remove the bush brackets with no problems.

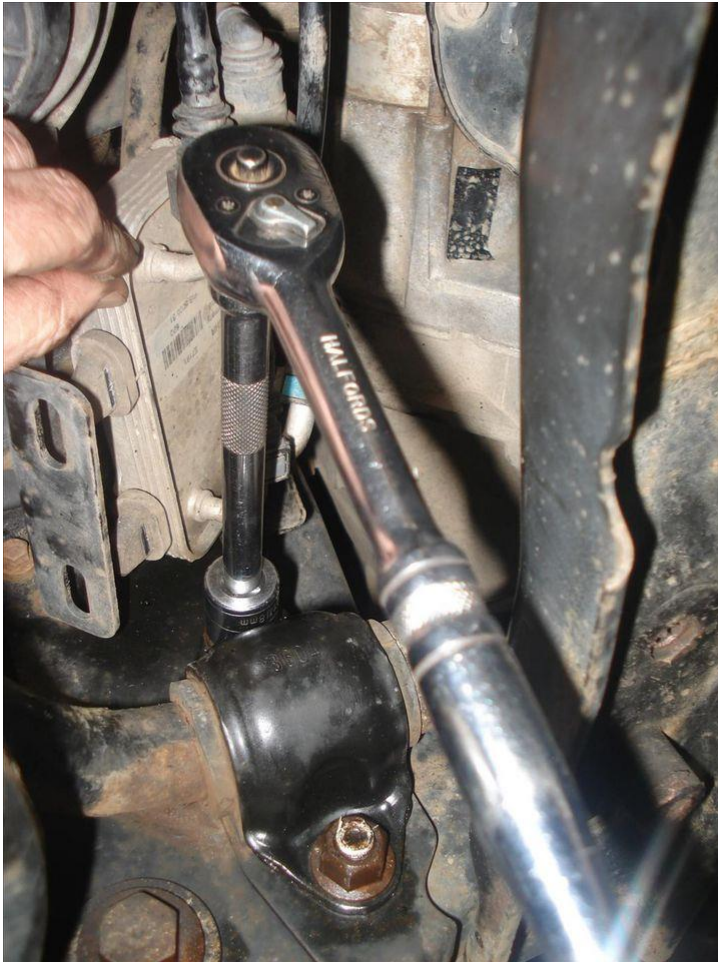
Starting on the drivers side bracket (RHD vehicle), firstly the fuel cooler bolt needs to be

removed allowing the cooler to be moved out of the way (see Mikey's thread for more info). This will allow you to get an 18mm socket onto the top nut, which is quite tightly done up (especially on my 05MY). Don't be tempted to leave the fuel cooler in place as you'll most likely damage it due to the lack of space - it's only held in place by a 10mm bolt, but access is a bit tricky and a ratchet spanner definitely helps.

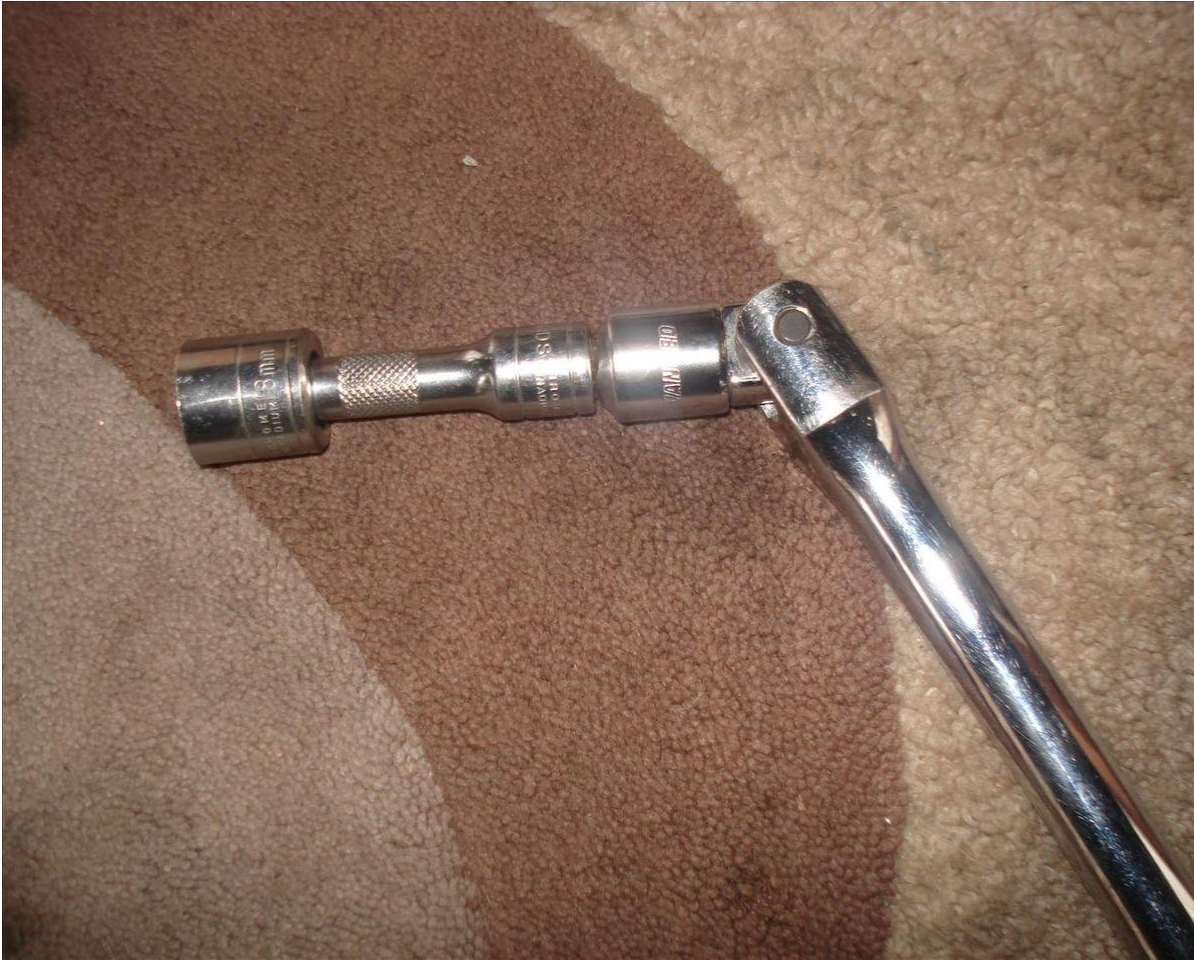
To get the ARB bracket nuts released initially I used a 1/2" breaker bar with 1/2 to 3/8 adapter, short 3/8 extension and 3/8 18mm socket. That gave enough leverage, which a 3/8 ratchet drive didn't.

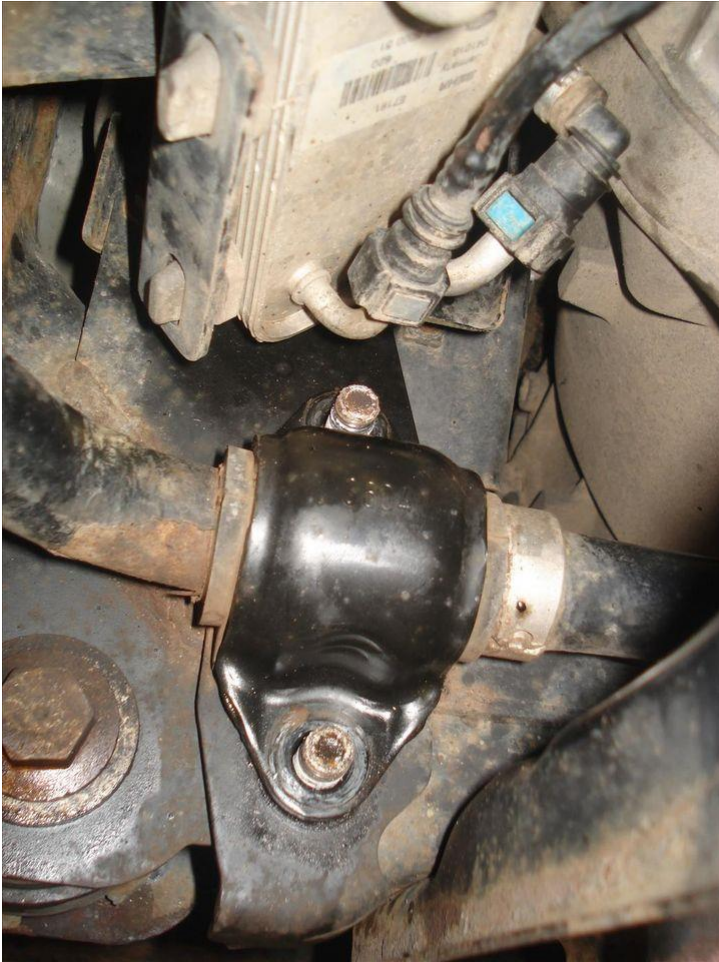
To highlight how tight the nuts are done up I actually snapped the 'male' end off my Halfords Pro 3/8" short extension trying to get one undone, and had to regrind the end to give me another 3/8 square section to fit in the back of the 18m socket!

With both nuts removed.....

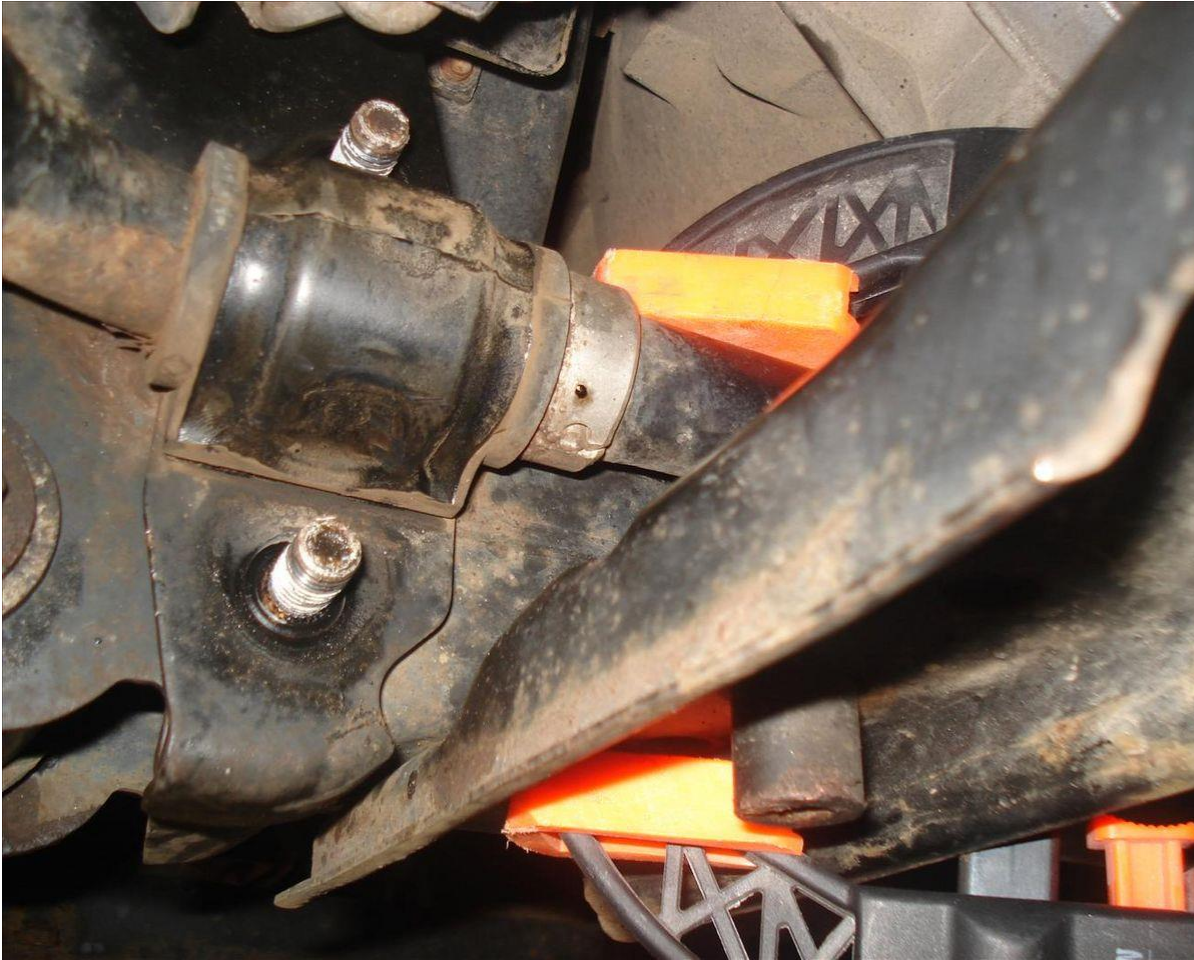
the metal bracket can be levered off using a screw driver, leaving just the rubber bush attached to the ARB....

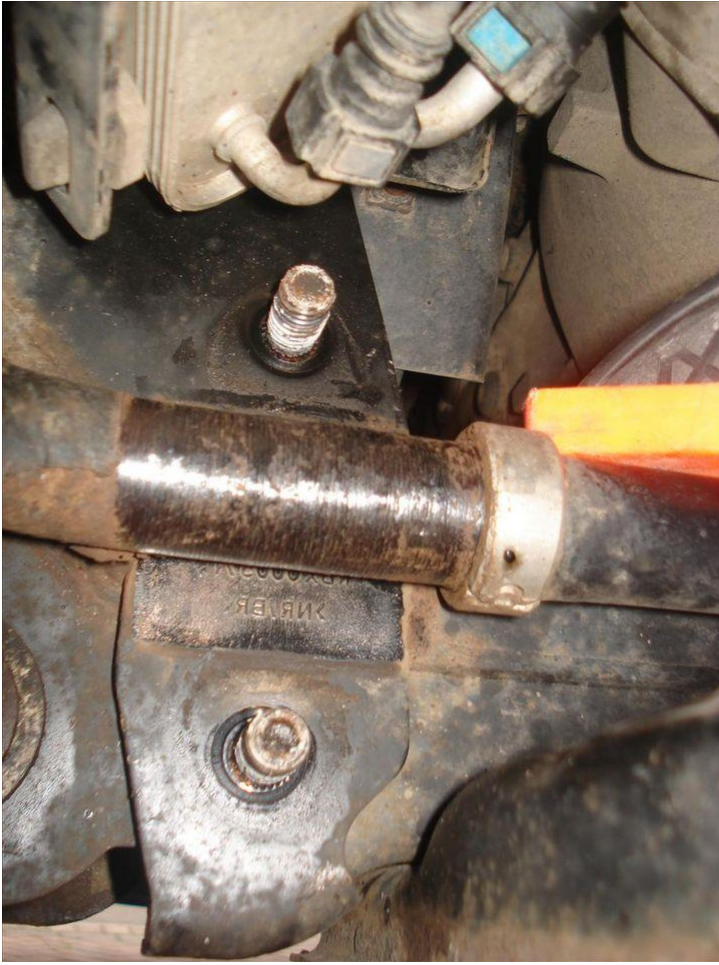
The orange clamp on the ARB wasn't necessary - I was just using it to make removing the clamp easier, thinking there was some tension on the bar, but there wasn't.

The old rubber bush is easy to remove by hand....

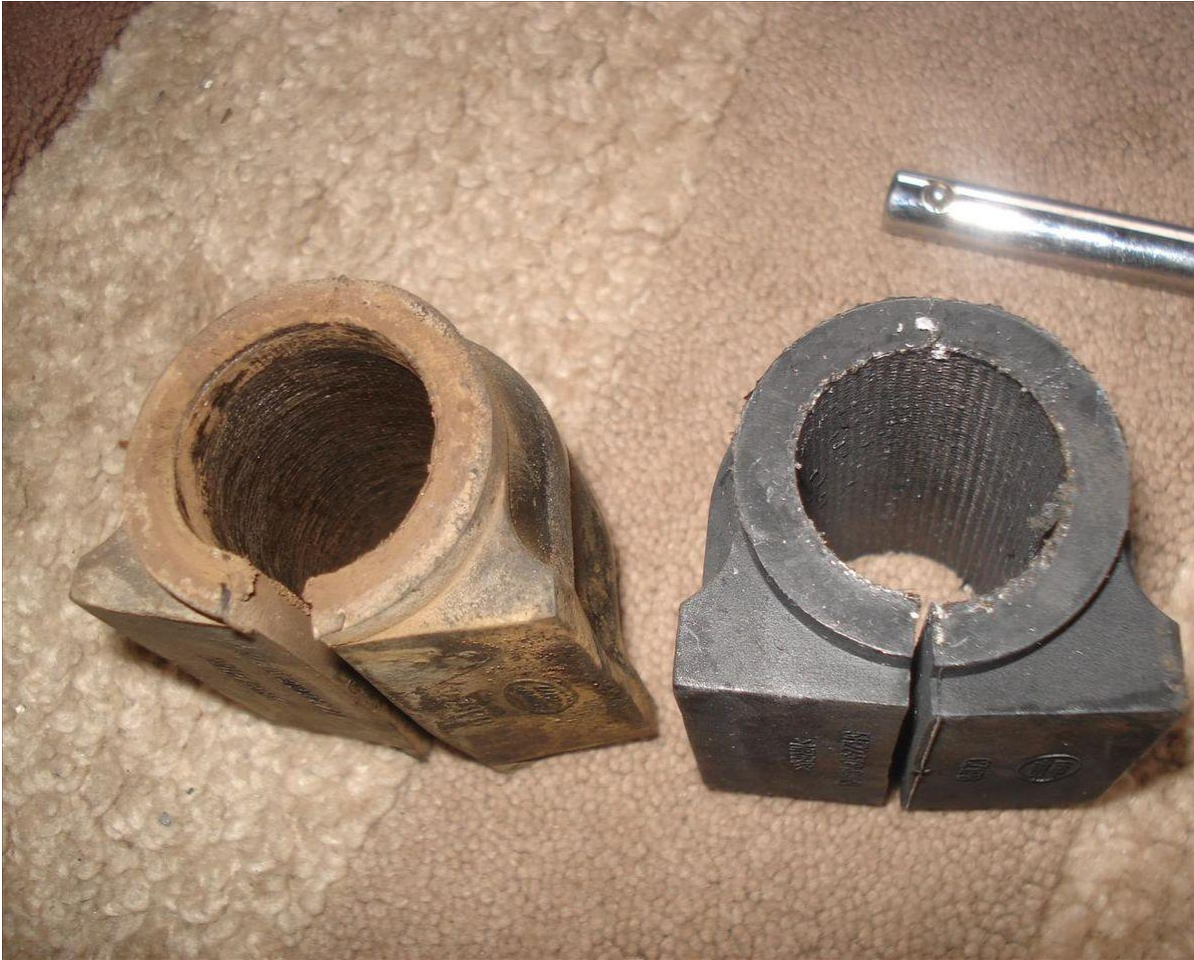
Comparing the old and new designs you can see the later bush is thicker at the base, so hopefully good for at least another 116000 miles 😊

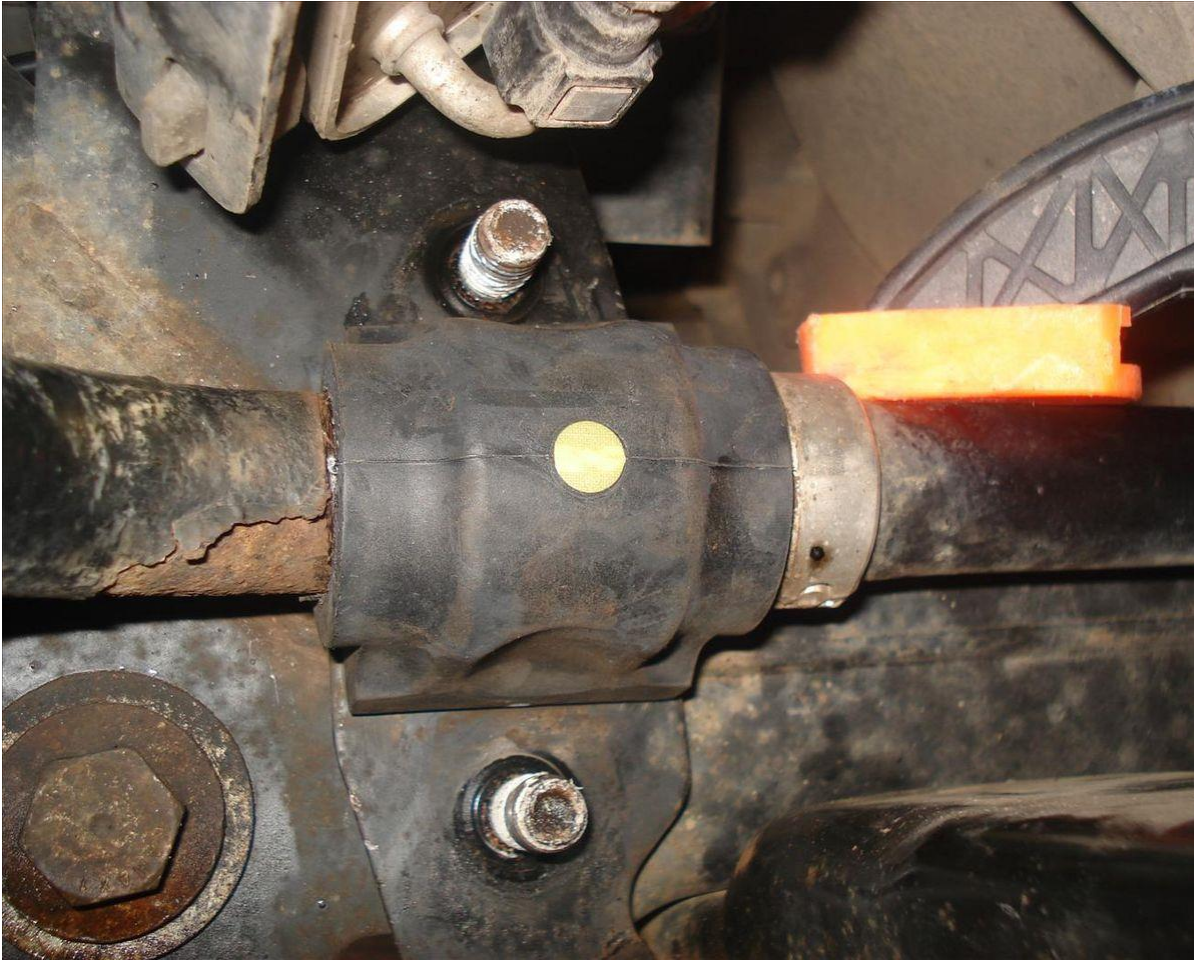
New bush placed on the ARB.....

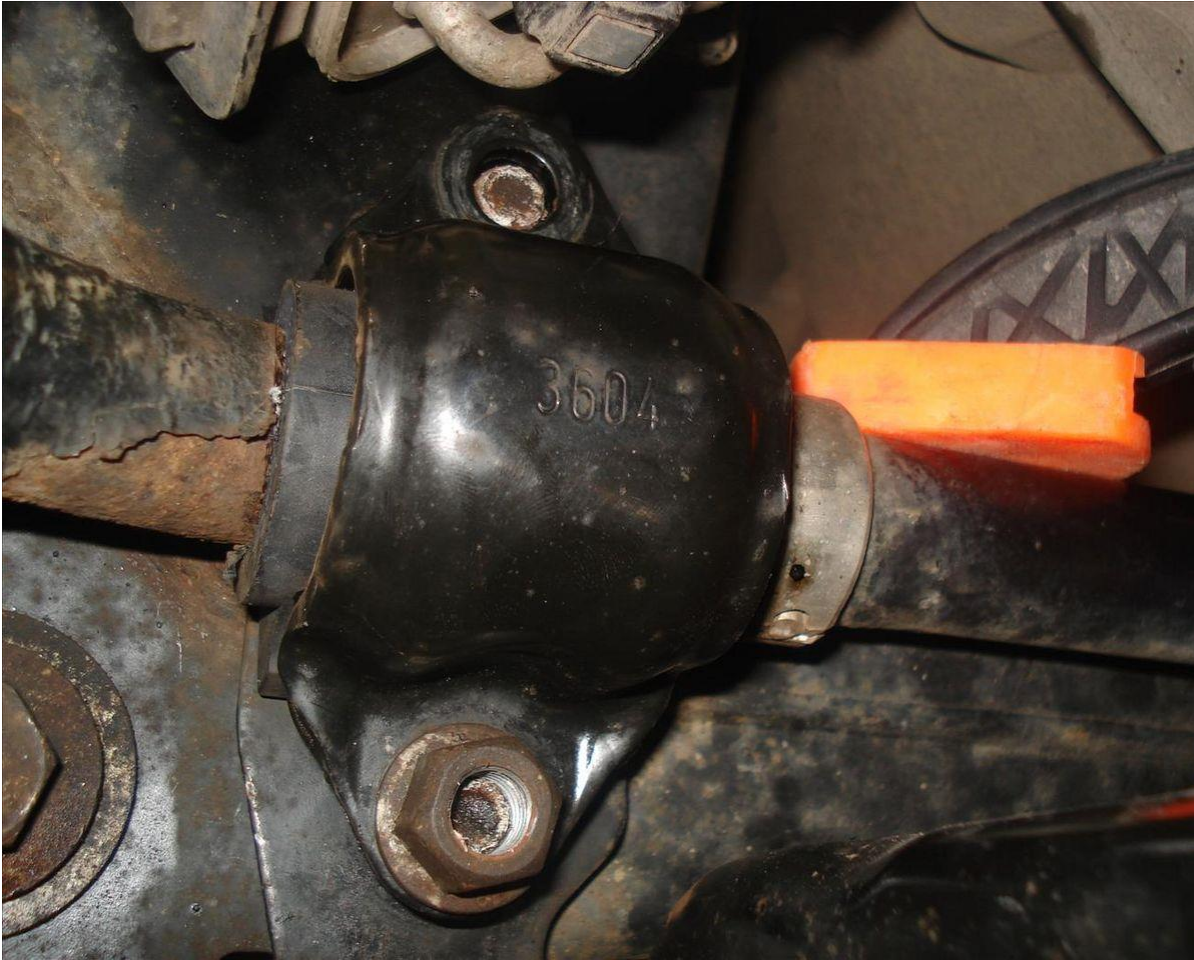
and bracket pushed onto it.....

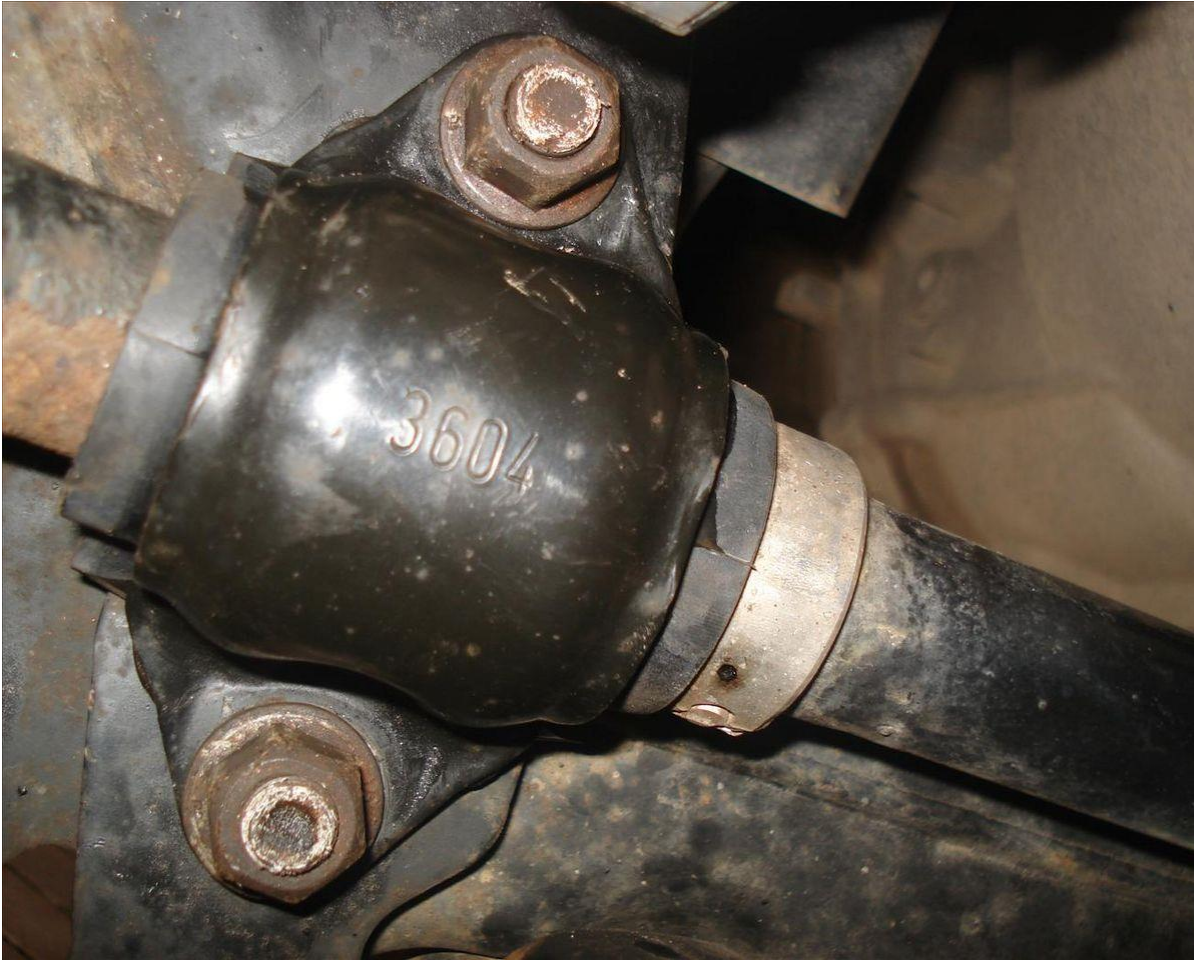
As the new rubber bush is a bit wider than the bracket, I used some washing up liquid to make it easier to fit on. Get 1 nut on by a few threads, then push the bracket onto the other stud and fit the 2nd nut (easier said than done, but OK with a bit of swearing and perseverance 😊)

Both nuts on and tightened to 115Nm / 85lb-ft.....

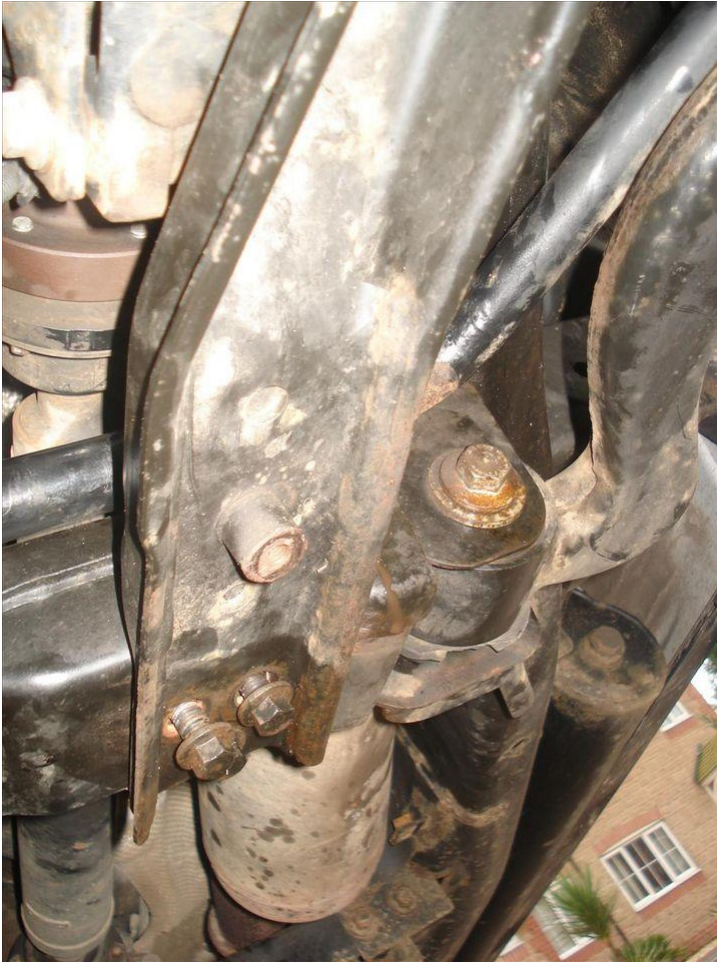
So, for the nearside ARB bracket you need to remove a cross member that sits under the front diff. The bolts are 15mm - 3 as shown and 1 more at the other end of the cross member. These are also quite tight to undo, so the breaker bar and 1/2 to 3/8" adapter are required again.

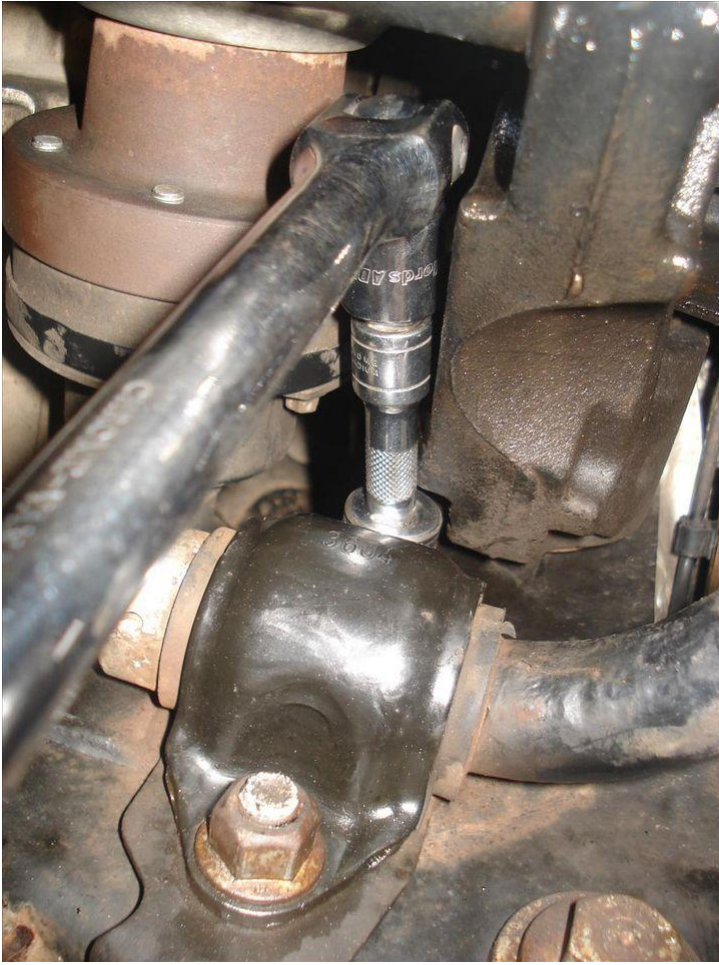
With the cross member out the way, you've got better access to the top nut, which will make you eff and blind big time! Land Rover in their wisdom managed to design about 15mm of clearance between the top stud and front diff bracket, so getting a socket, extension bar and drive onto it is very difficult. This is where I managed to snap the male end off my 3/8" short extension, hence the need to regrind the square back onto it. There was no way this nut was coming loose without using the breaker bar, but eventually it came unstuck, using the combination in the 3rd picture above (from the top).

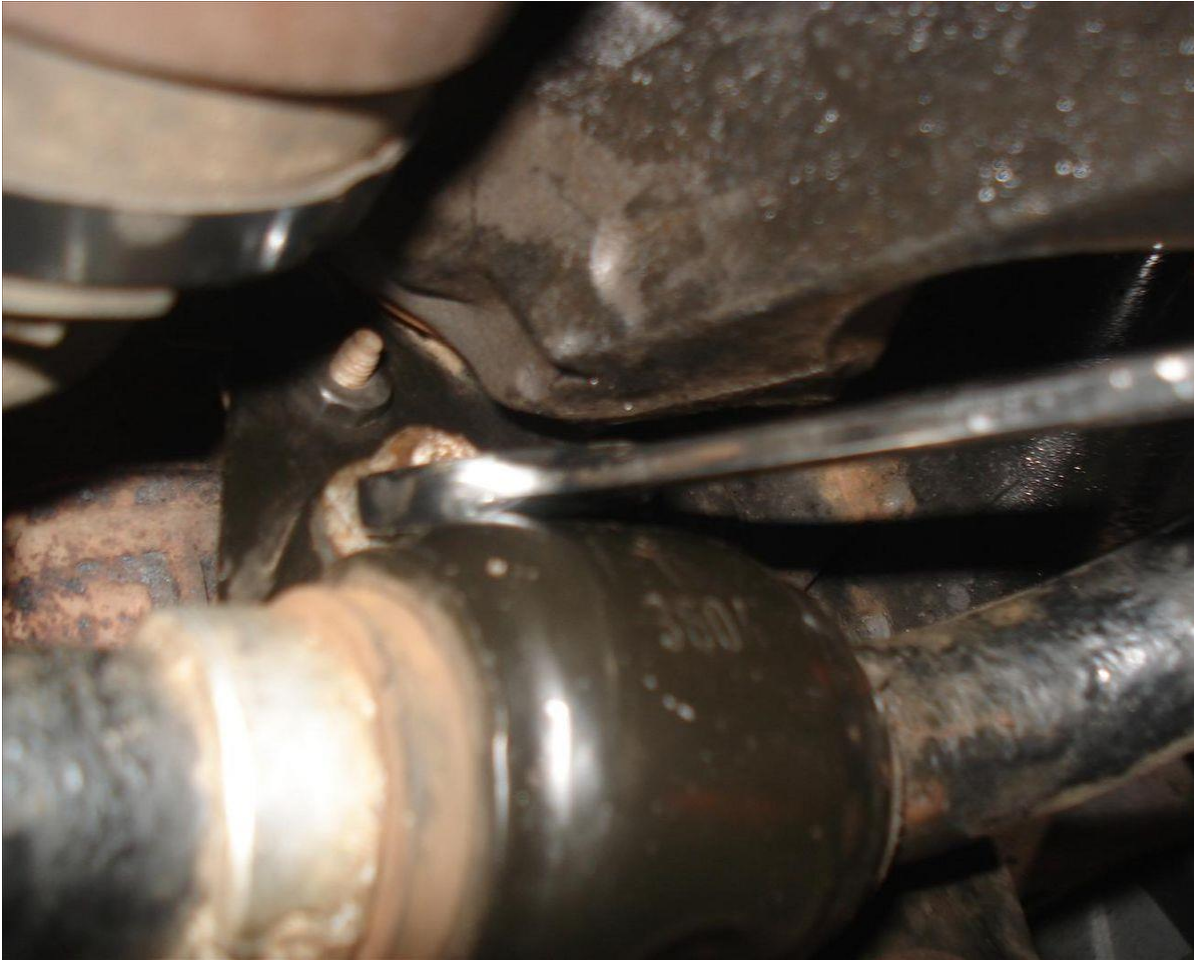
You will only be able to use the socket for a couple of turns before it gets trapped onto the nut by the diff bracket. Before this happens you will need to take the socket off and use an 18mm open ended spanner.....

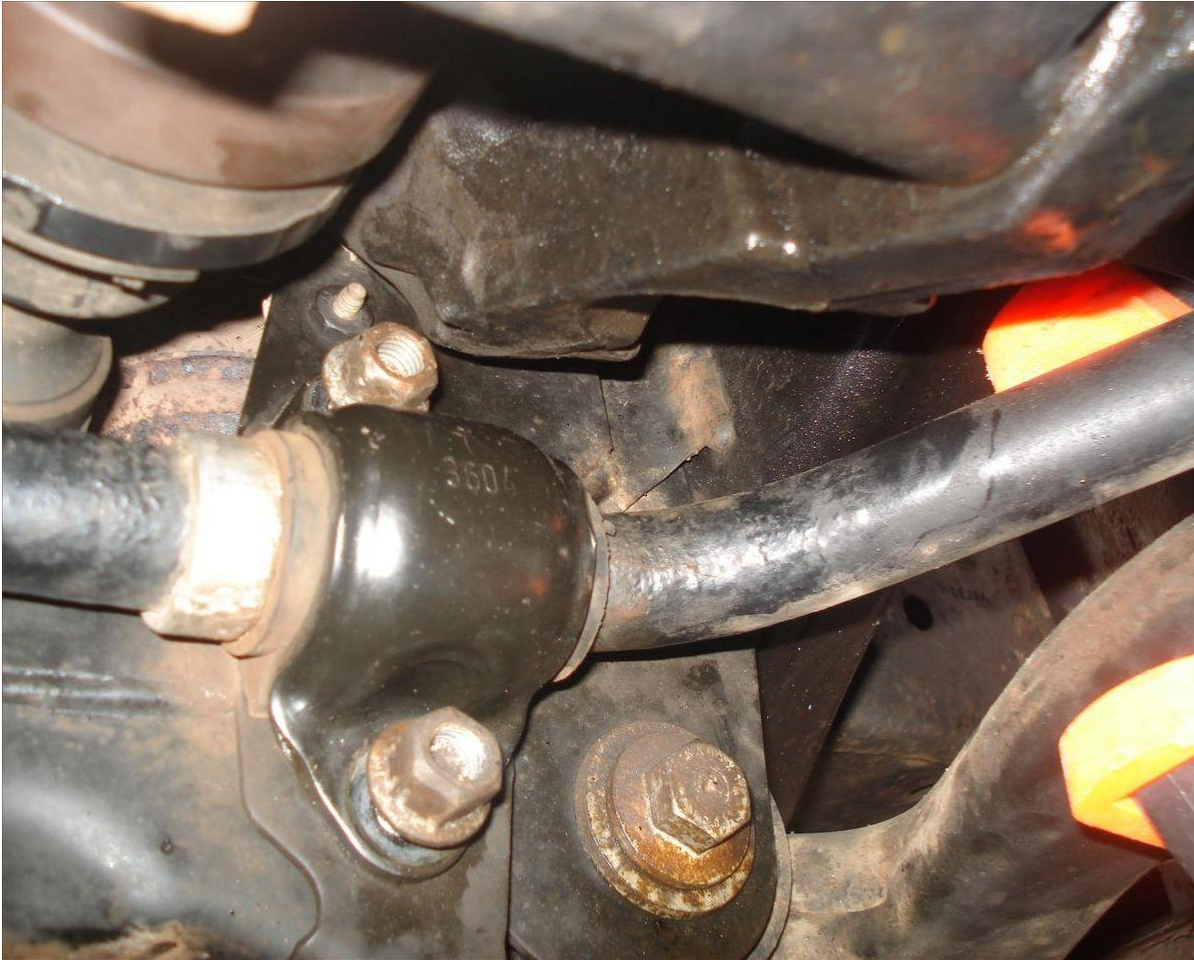
Patience is needed at this point, as you don't want to start rounding off the nut before it's off! There maybe another way, but I had no other tools that would fit in there once the nut started backing off towards the diff mount.

You can see from this picture how tight it is around the top nut....

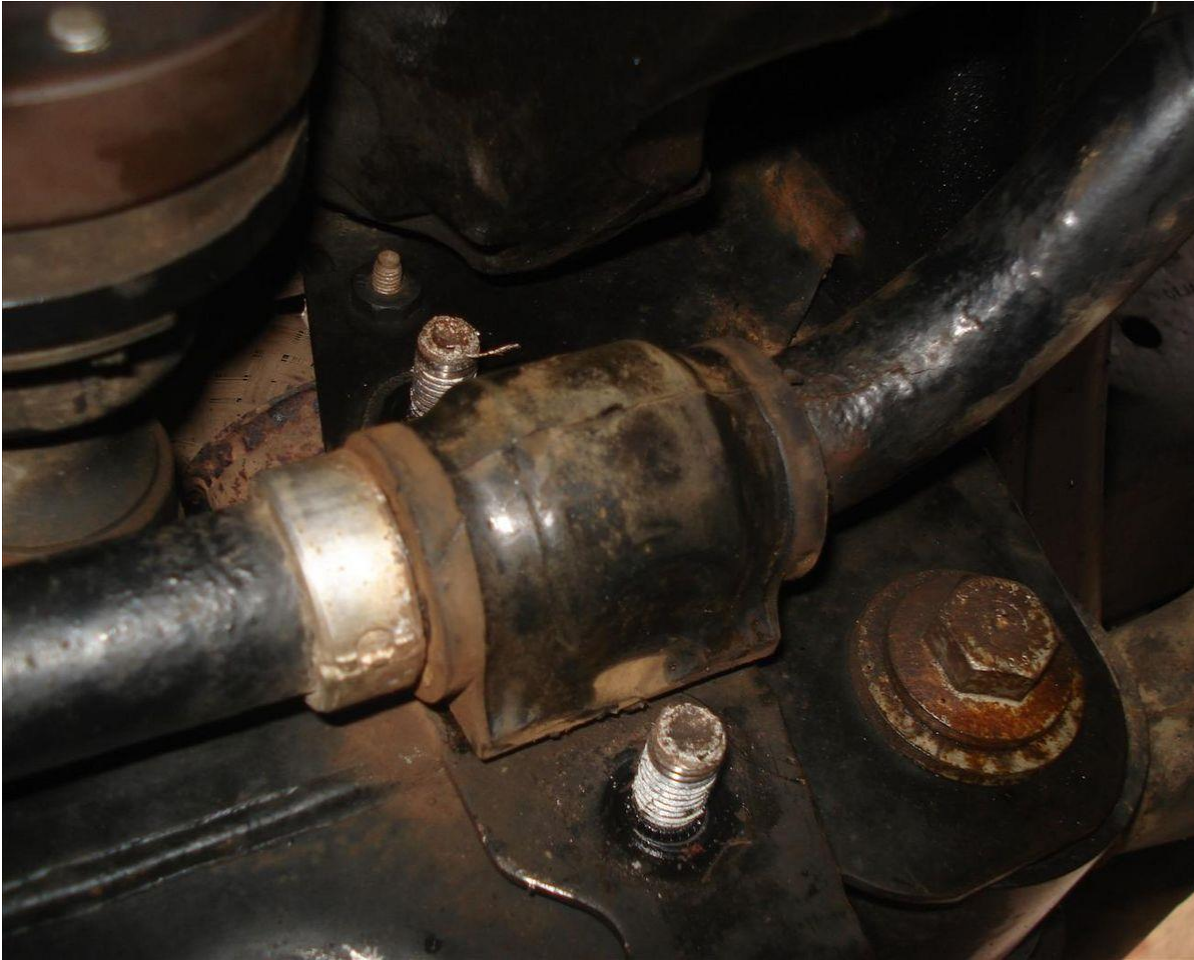
Eventually you'll get to this point, where the bracket is off and the old bush is ready to be removed...

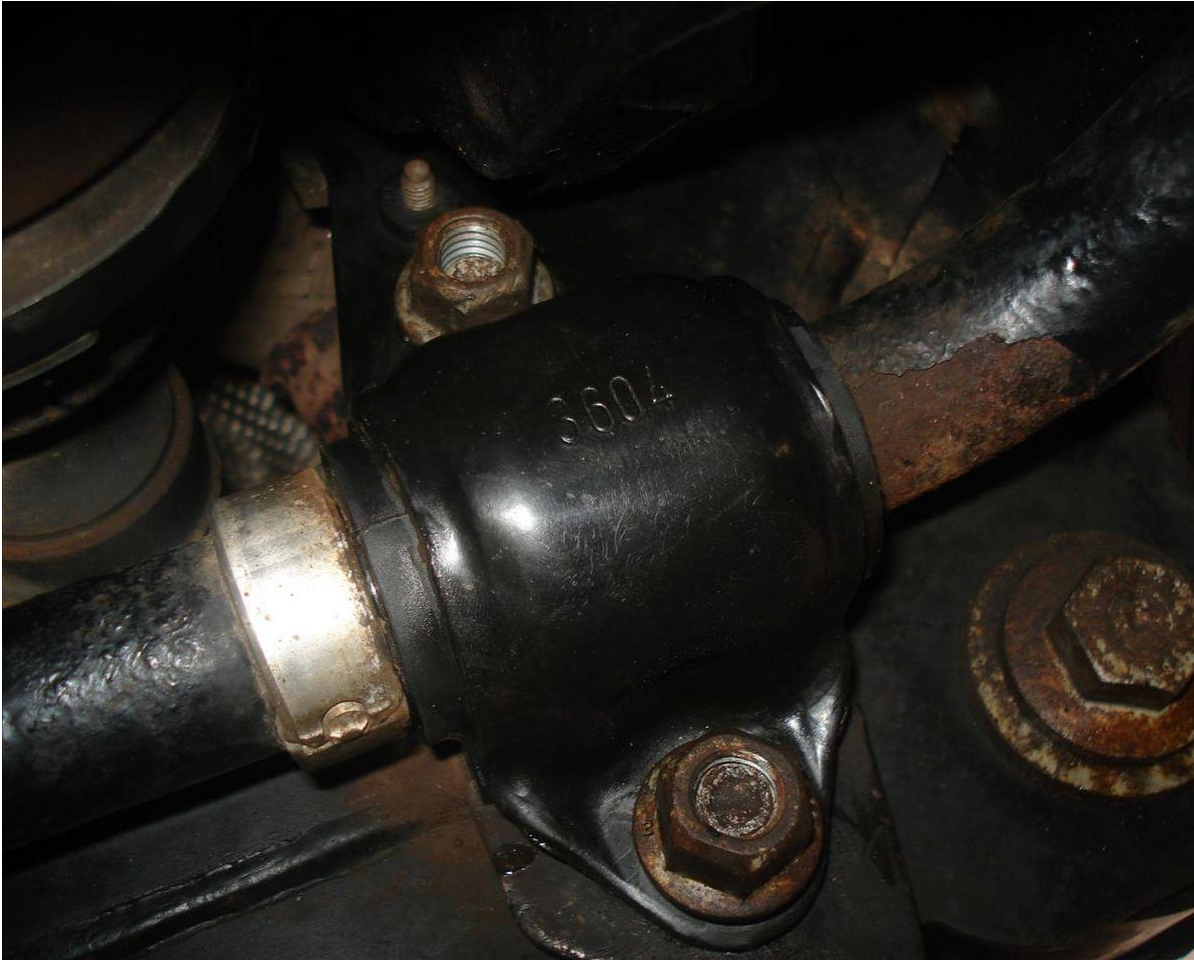
and just like the other side, new bush on, bracket in place, nuts ready to tighten. Again, you will need to use a spanner to tighten the top nut until it's far enough on to get the socket back on. I resorted to grinding away some of the back edge of my 18mm socket so I could get it onto the nut sooner, for the final stage of tightening.

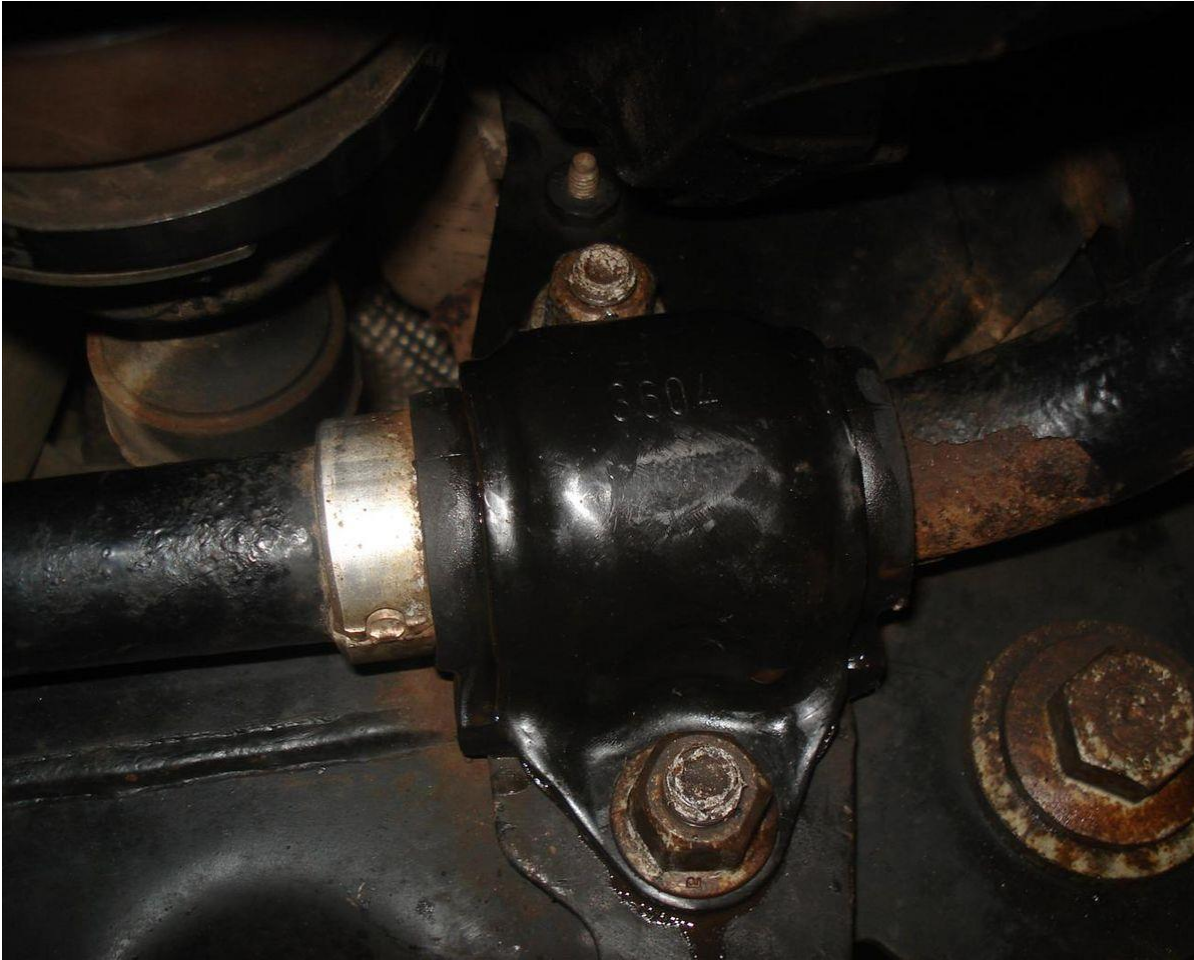
Both nuts torqued up to 115Nm.....

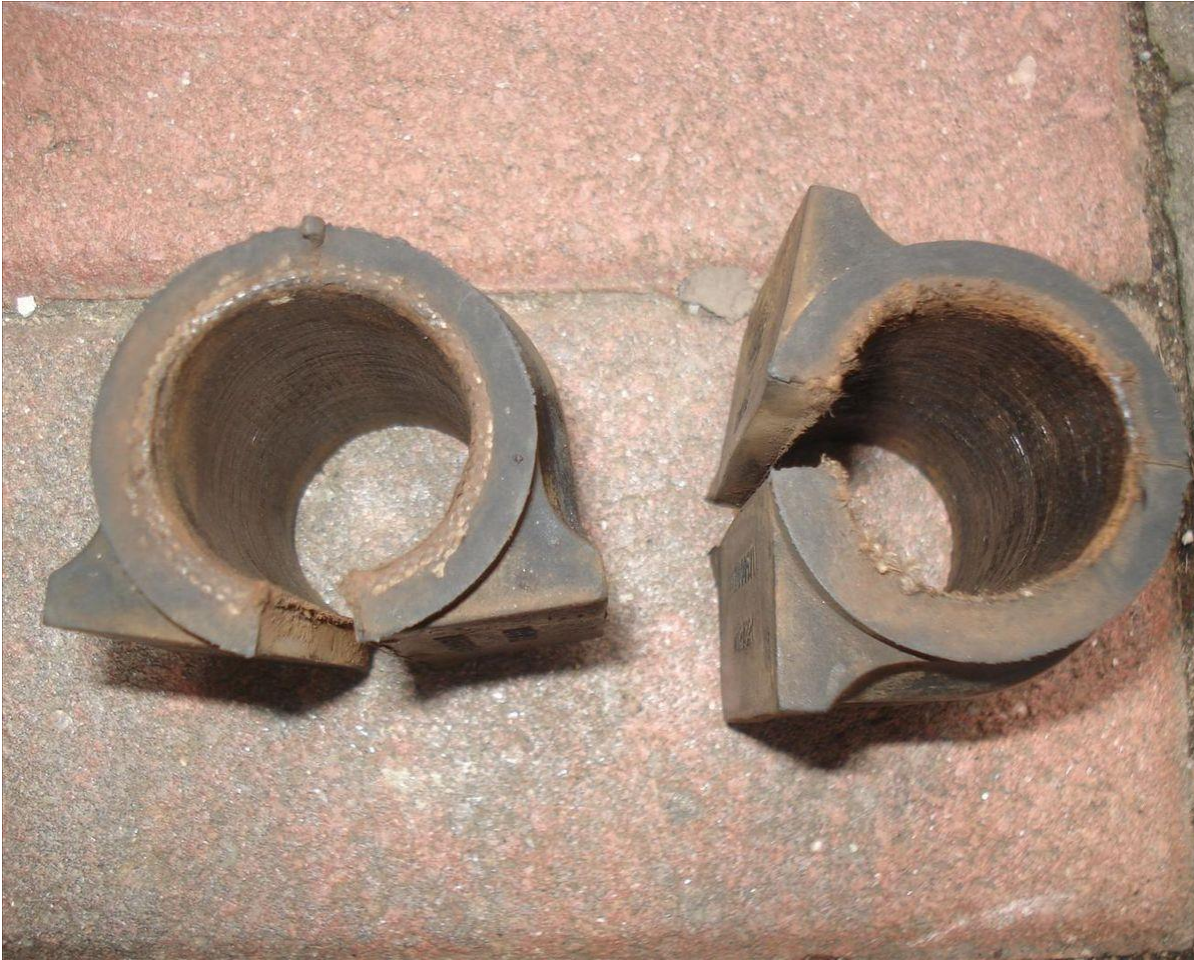
2 very well used ARB bushes!
